OIL ANALYSIS REPORT

Area
AREA I [500315361]
 Machine Id
LIGHTNIN A1403 (S/N AD-30-8)
 Component
Gearbox
 Fluid
ROYAL PURPLE SYNFILM GT 220 (7 GAL)

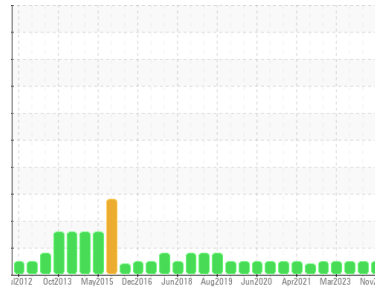
Sample Rating Trend

NORMAL

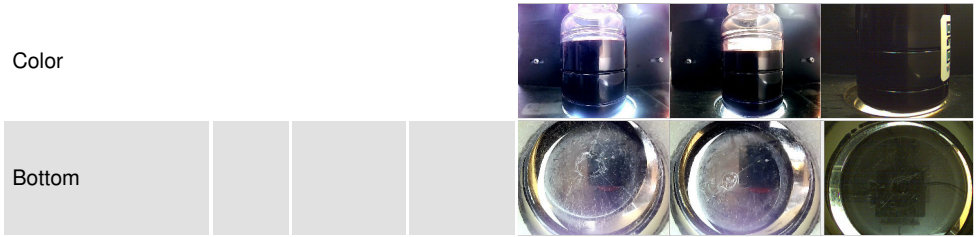
SAMPLE IMAGES	method	limit/base	current	history1	history2
---------------	--------	------------	---------	----------	----------

VISUAL	method	limit/base	current	history1	history2
White Metal	scalar	*Visual	NONE	NONE	NONE
Yellow Metal	scalar	*Visual	NONE	NONE	NONE
Precipitate	scalar	*Visual	NONE	NONE	NONE
Silt	scalar	*Visual	NONE	NONE	NONE
Debris	scalar	*Visual	NONE	NONE	NONE
Sand/Dirt	scalar	*Visual	NONE	NONE	NONE
Appearance	scalar	*Visual	NORML	NORML	NORML
Odor	scalar	*Visual	NORML	NORML	NORML
Emulsified Water	scalar	*Visual	>0.2	NEG	NEG
Free Water	scalar	*Visual		NEG	NEG
