OIL ANALYSIS REPORT

Machine Id
NISSEI B-08 - S22211025K1

Component
Hydraulic System

Fluid
AW HYDRAULIC OIL ISO 46 (--- GAL)

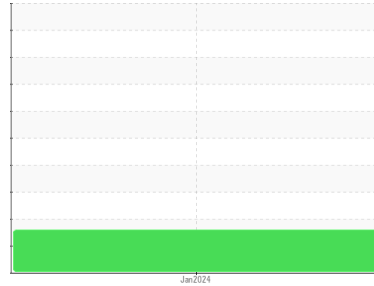
Sample Rating Trend

The copper level is abnormal. All other component wear rates are normal.

There is a high amount of silt (particulates < 14 microns in size) present in the oil.

No corrective action is recommended at this time. Resample at the next service interval to monitor.
