# PROBLEM SUMMARY

Area  
**ACAS 115 [7824]**  
 Machine Id  
**ATLAS COPCO ITJ436169**  
 Component  
**Compressor**

# OIL ANALYSIS REPORT

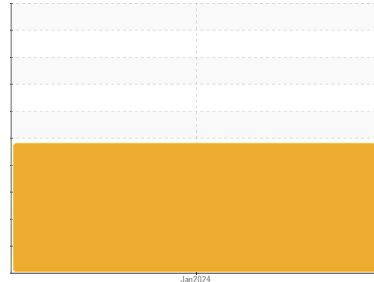
Sample Rating Trend

**WATER**

Sample Status			<b>SEVERE</b>	---	---
Free Water	scalar	*Visual	<b>5.0</b>	---	---

We advise that you follow the water drain-off procedure for this component. The filter change at the time of sampling has been noted. Resample at the next service interval to monitor.

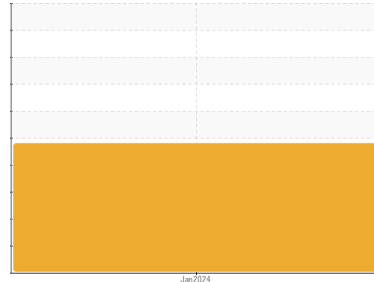
Sample Rating Trend

WATER

Excessive free water present. Moderate concentration of visible dirt/debris present in the oil.

We advise that you follow the water drain-off procedure for this component. The filter change at the time of sampling has been noted. Resample at the next service interval to monitor.
