OIL ANALYSIS REPORT

Machine Id
ALSTOM R176
 Component
Gearbox
 Fluid
TOTAL CARTER SH 220 (3 GAL)

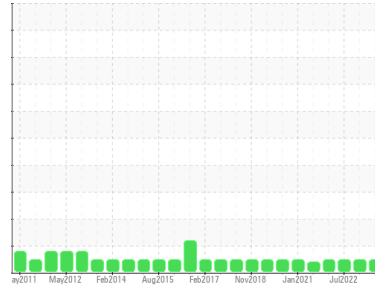
Sample Rating Trend

NORMAL

Resample at the next service interval to monitor.

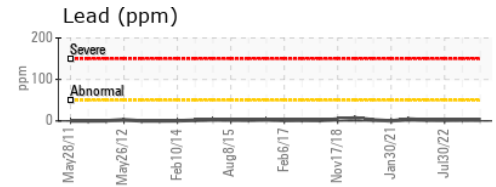
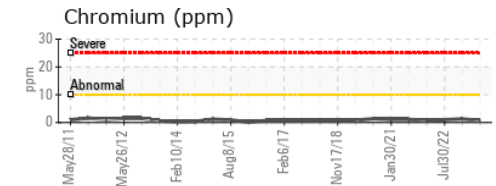
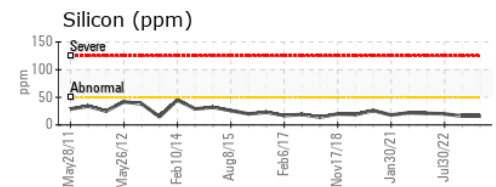
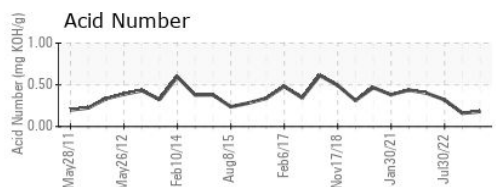
GRAPHS

All component wear rates are normal.

There is no indication of any contamination in the oil.

The AN level is acceptable for this fluid. The condition of the oil is suitable for further service.
