OIL ANALYSIS REPORT

Laboratory : WearCheck USA - 501 Madison Ave., Cary, NC 27513
Sample No. : MH1026353 **Received** : 31 Jan 2024
Lab Number : **06075773** **Tested** : 01 Feb 2024
Unique Number : 10857864 **Diagnosed** : 01 Feb 2024 - Don Baldrige
Test Package : IND 2 (Additional Tests: KF, PQ)

DIAMOND WTG - MOUNTAIN VIEW IV
P.O. BOX 880
DESERT HOT SPRINGS, CA
US 92240
Contact: SERVICE MANAGER

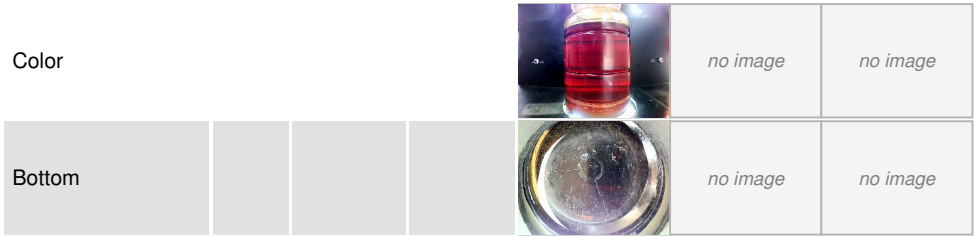
SAMPLE IMAGES	method	limit/base	current	history1	history2
---------------	--------	------------	---------	----------	----------

VISUAL	method	limit/base	current	history1	history2
White Metal	scalar	*Visual	NONE	NONE	---
Yellow Metal	scalar	*Visual	NONE	NONE	---
Precipitate	scalar	*Visual	NONE	NONE	---
Silt	scalar	*Visual	NONE	NONE	---
Debris	scalar	*Visual	NONE	NONE	---
Sand/Dirt	scalar	*Visual	NONE	NONE	---
Appearance	scalar	*Visual	NORML	NORML	---
Odor	scalar	*Visual	NORML	NORML	---
Emulsified Water	scalar	*Visual	>0.1	NEG	---
Free Water	scalar	*Visual		NEG	---
