OIL ANALYSIS REPORT

Area
ROTO XTEND DUTY
 Machine Id
ATLAS COPCO AIF116207 - UVA
 Component
Compressor

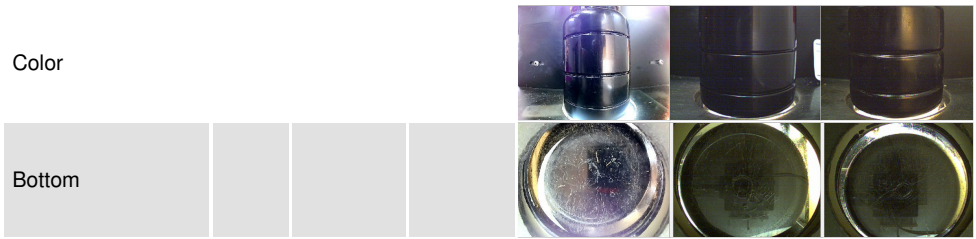
SAMPLE IMAGES	method	limit/base	current	history1	history2
---------------	--------	------------	---------	----------	----------

VISUAL	method	limit/base	current	history1	history2
White Metal	scalar	*Visual	NONE	NONE	NONE
Yellow Metal	scalar	*Visual	NONE	NONE	NONE
Precipitate	scalar	*Visual	NONE	NONE	NONE
Silt	scalar	*Visual	NONE	NONE	NONE
Debris	scalar	*Visual	NONE	NONE	NONE
Sand/Dirt	scalar	*Visual	NONE	NONE	NONE
Appearance	scalar	*Visual	NORML	NORML	NORML
Odor	scalar	*Visual	NORML	NORML	NORML
Emulsified Water	scalar	*Visual	>0.1	NEG	NEG
Free Water	scalar	*Visual		NEG	NEG

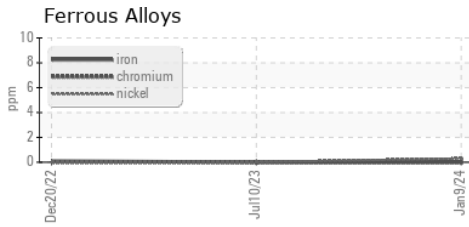
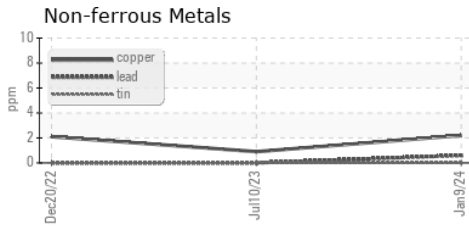
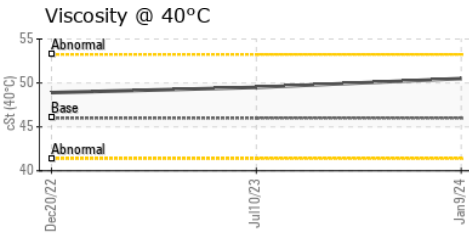
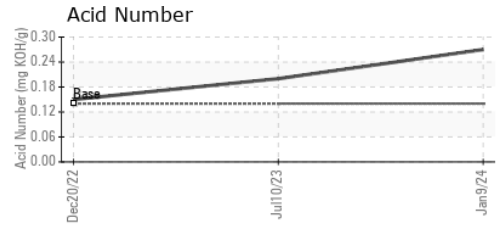
GRAPHS

All component wear rates are normal.

The AN level is acceptable for this fluid. The condition of the oil is suitable for further service.

Resample at the next service interval to monitor.
