OIL ANALYSIS REPORT

Area
[978962]
 Machine Id
K9 COMPRESSOR 4
 Component
Compressor
 Fluid
{not provided} (--- GAL)

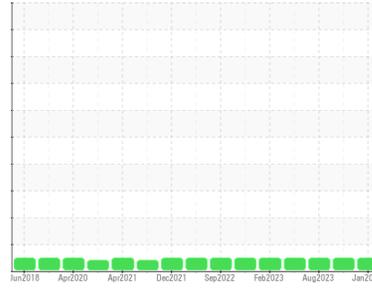
Sample Rating Trend

NORMAL

Wear
 All component wear rates are normal.

Contamination
 There is no indication of any contamination in the oil.

Fluid Condition
 The AN level is acceptable for this fluid. The condition of the oil is suitable for further service.

Recommendation
 Resample at the next service interval to monitor.

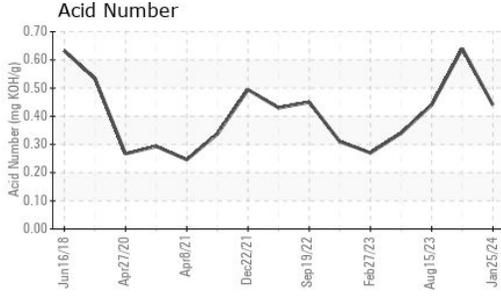
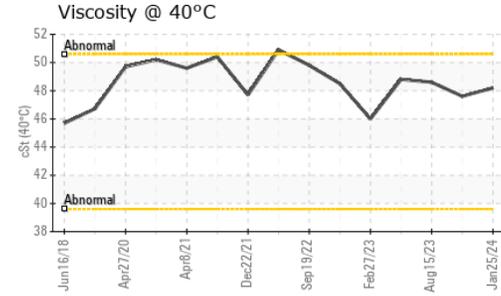
VISUAL	method	limit/base	current	history1	history2
White Metal	scalar	*Visual	NONE	NONE	NONE
Yellow Metal	scalar	*Visual	NONE	NONE	NONE
Precipitate	scalar	*Visual	NONE	NONE	NONE
Silt	scalar	*Visual	NONE	NONE	NONE
Debris	scalar	*Visual	NONE	NONE	LIGHT
Sand/Dirt	scalar	*Visual	NONE	NONE	NONE
Appearance	scalar	*Visual	NORML	NORML	NORML
Odor	scalar	*Visual	NORML	NORML	NORML
Emulsified Water	scalar	*Visual	>0.1	NEG	NEG
Free Water	scalar	*Visual		NEG	NEG

FLUID PROPERTIES	method	limit/base	current	history1	history2
Visc @ 40°C	cSt	ASTM D445	48.2	47.6	48.6
