OIL ANALYSIS REPORT

Machine Id
ALSTOM R094

Component
Gearbox

Fluid
TOTAL CARTER SH 220 (3 GAL)

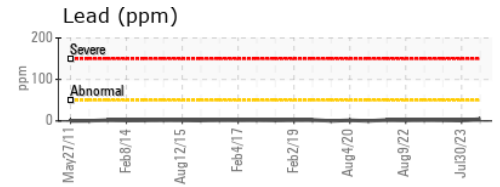
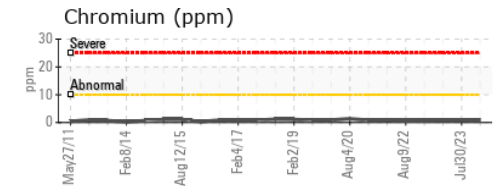
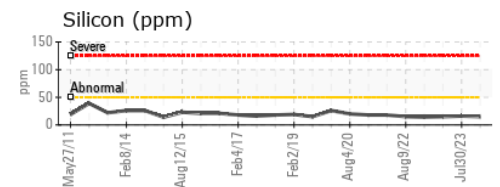
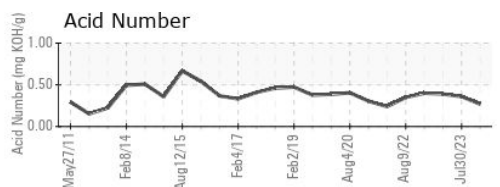
GRAPHS

All component wear rates are normal.

There is no indication of any contamination in the oil.

The AN level is acceptable for this fluid. The condition of the oil is suitable for further service.

Resample at the next service interval to monitor.
