OIL ANALYSIS REPORT

Machine Id
RESIN R3
 Component
Hydraulic System
 Fluid
{not provided} (--- GAL)

Laboratory : WearCheck USA - 501 Madison Ave., Cary, NC 27513
Sample No. : PH0003242 **Received** : 22 Feb 2024
Lab Number : 06097656 **Tested** : 26 Feb 2024
Unique Number : 10890509 **Diagnosed** : 26 Feb 2024 - Jonathan Hester
Test Package : PLANT (Additional Tests: PrtFilter)

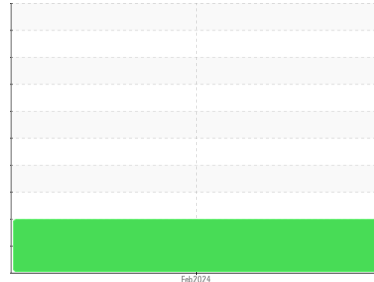
Sample Rating Trend

The iron level is abnormal. All other component wear rates are normal.

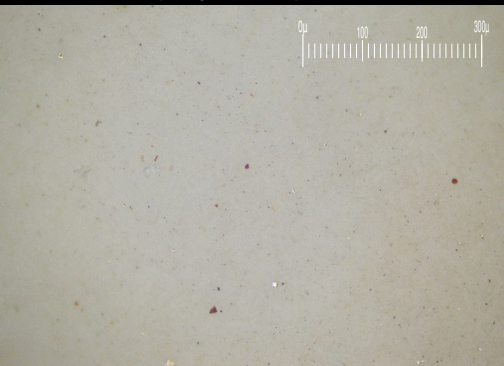
Particle Filter (Magn: 200 x)

There is a high amount of silt (particulates < 14 microns in size) present in the oil.

No corrective action is recommended at this time. We recommend an early resample to monitor this condition. Please specify the brand, type, and viscosity of the oil on your next sample.
