Area
SMART OIL
Machine Id
HERTZ VD014853 - CUSTOM INTERIOR DYNAMICS
Component
Compressor
Fluid
SMARTOIL 6000 (--- GAL)

OIL ANALYSIS REPORT

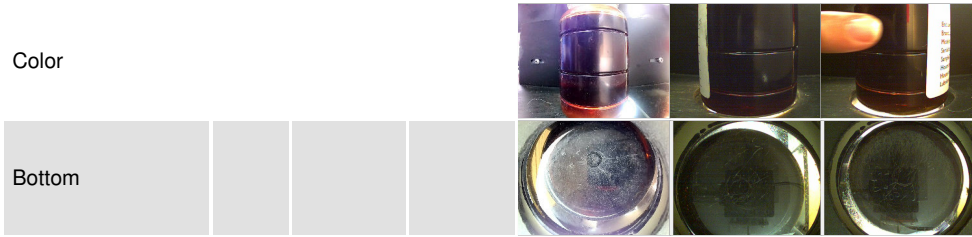
SAMPLE IMAGES	method	limit/base	current	history1	history2
---------------	--------	------------	---------	----------	----------

VISUAL	method	limit/base	current	history1	history2
White Metal	scalar	*Visual	NONE	NONE	NONE
Yellow Metal	scalar	*Visual	NONE	NONE	NONE
Precipitate	scalar	*Visual	NONE	NONE	NONE
Silt	scalar	*Visual	NONE	NONE	NONE
Debris	scalar	*Visual	NONE	NONE	LIGHT
Sand/Dirt	scalar	*Visual	NONE	NONE	NONE
Appearance	scalar	*Visual	NORML	NORML	NORML
Odor	scalar	*Visual	NORML	NORML	NORML
Emulsified Water	scalar	*Visual	>0.1	NEG	0.2%
Free Water	scalar	*Visual		NEG	1.0
