# **OIL ANALYSIS REPORT**

# TOLE\_U2 TOLE\_U2\_P2

**Drive End Pump**

**ROYAL PURPLE SYNFILM GT 32 (2 QTS)**

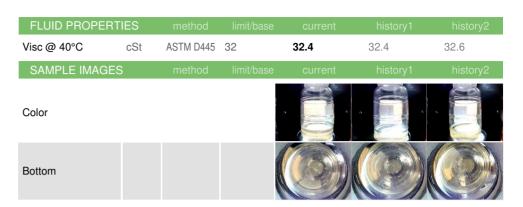
## **GRAPHS**

All component wear rates are normal.

The water content is negligible. There is no indication of any contamination in the oil.

The AN level is acceptable for this fluid. The condition of the oil is suitable for further service.

Resample at the next service interval to monitor.
