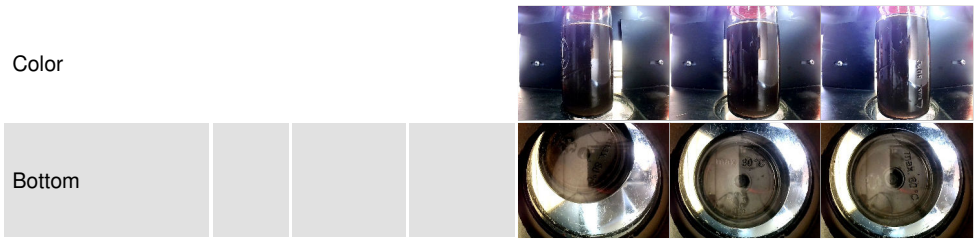
SAMPLE IMAGES	method	limit/base	current	history1	history2
---------------	--------	------------	---------	----------	----------

VISUAL	method	limit/base	current	history1	history2
White Metal	scalar	*Visual	NONE	NONE	NONE
Yellow Metal	scalar	*Visual	NONE	NONE	NONE
Precipitate	scalar	*Visual	NONE	NONE	NONE
Silt	scalar	*Visual	NONE	NONE	NONE
Debris	scalar	*Visual	NONE	HEAVY	HEAVY
Sand/Dirt	scalar	*Visual	NONE	NONE	NONE
Appearance	scalar	*Visual	NORML	NORML	NORML
Odor	scalar	*Visual	NORML	NORML	NORML
Emulsified Water	scalar	*Visual	>0.1669	NEG	NEG
Free Water	scalar	*Visual		NEG	NEG

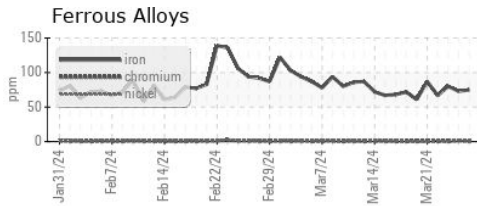
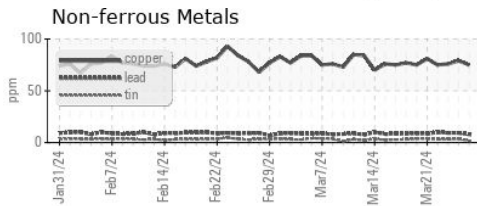
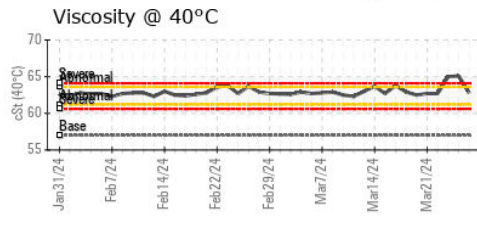
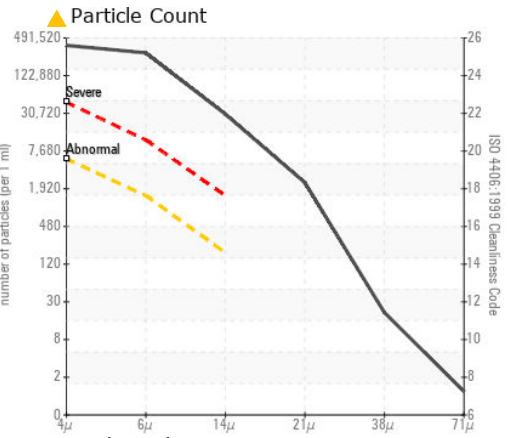
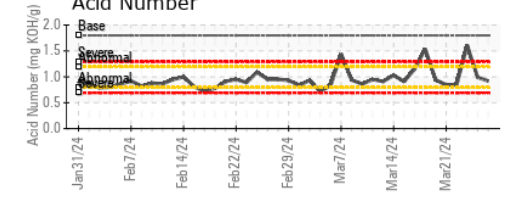
GRAPHS

FLUID PROPERTIES	method	limit/base	current	history1	history2
Visc @ 40°C	cSt	ASTM D445	57.0	62.8	65.1
Visc @ 100°C	cSt	ASTM D445	9.4	9.2	9.1
Viscosity Index (VI)	Scale	ASTM D2270	147	124	118
