OIL ANALYSIS REPORT

Area
VACUUM PUMP
 Machine Id
B72429 TOP ROTARY VANE PUMP
 Component
Vacuum Pump
 Fluid
BUSCH R530S (--- GAL)

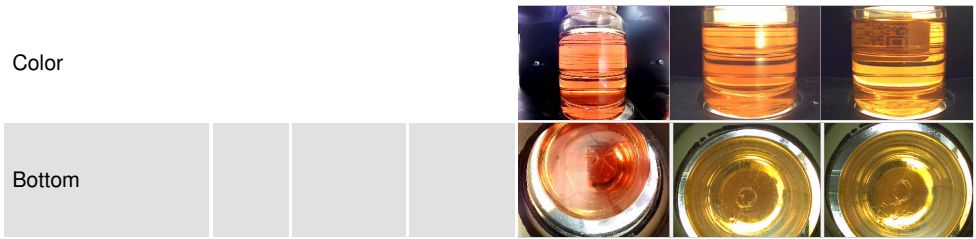
| SAMPLE IMAGES | method | limit/base | current | history1 | history2 |

| VISUAL | method | limit/base | current | history1 | history2 |
|---|---|---|---|---|---|
| Appearance | scalar | *Visual | NORML | NORML | NORML |
| Odor | scalar | *Visual | NORML | NORML | NORML |
