# OIL ANALYSIS REPORT

Machine Id  
**FRICK PROPANE 1**  
 Component  
**Refrigeration Compressor**  
 Fluid  
**SUMMIT PGI 100 (--- GAL)**

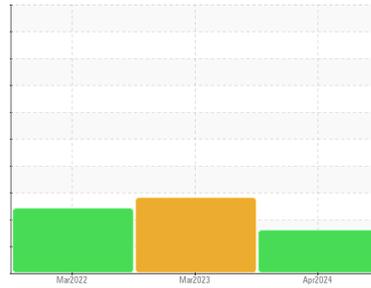
Sample Rating Trend

There is a trace of moisture present in the oil. The amount and size of particulates present in the system are acceptable.

No corrective action is recommended at this time. Resample at the next service interval to monitor.
