OIL ANALYSIS REPORT

Machine Id
CATERPILLAR D10T 15105049 (S/N CATOD10TCRJG01495)
 Component
Left Final Drive
 Fluid
CHEVRON 50WT (--- GAL)

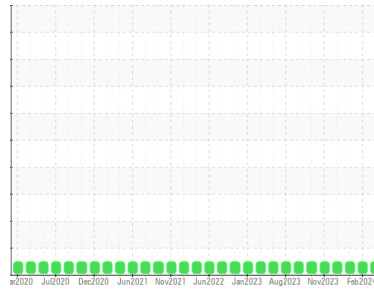
Sample Rating Trend

- Recommendation**
Resample at the next service interval to monitor.
- Wear**
All component wear rates are normal.
- Contamination**
There is no indication of any contamination in the oil.
- Fluid Condition**
The AN level is acceptable for this fluid. The condition of the oil is suitable for further service.

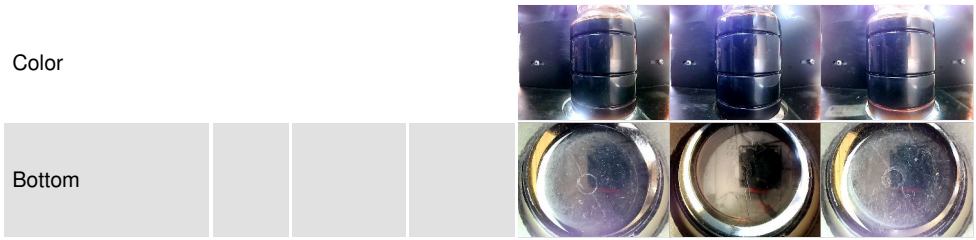
SAMPLE IMAGES		method	limit/base	current	history1	history2
---------------	--	--------	------------	---------	----------	----------

method	limit/base	current	history1	history2
White Metal	scalar	*Visual NONE	NONE	NONE	NONE
Yellow Metal	scalar	*Visual NONE	NONE	NONE	NONE
Precipitate	scalar	*Visual NONE	NONE	NONE	NONE
Silt	scalar	*Visual NONE	NONE	NONE	NONE
Debris	scalar	*Visual NONE	NONE	NONE	NONE
Sand/Dirt	scalar	*Visual NONE	NONE	NONE	NONE
Appearance	scalar	*Visual NORML	NORML	NORML	NORML
Odor	scalar	*Visual NORML	NORML	NORML	NORML
Emulsified Water	scalar	*Visual >0.2	NEG	NEG	NEG
Free Water	scalar	*Visual	NEG	NEG	NEG

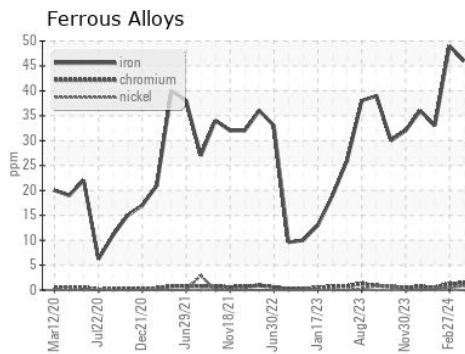
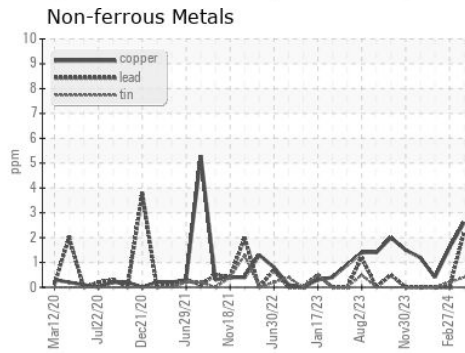
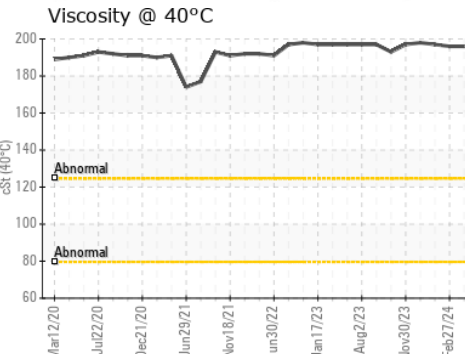
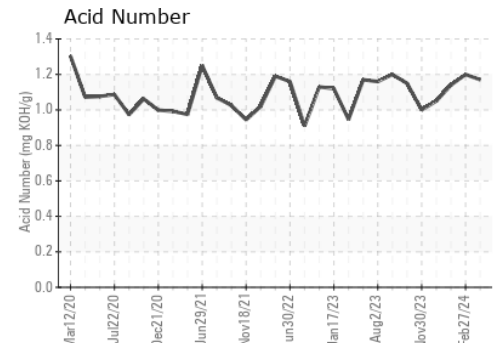
GRAPHS

method	limit/base	current	history1	history2
Iron	ppm	ASTM D5185m >800	46	49	33
Chromium	ppm	ASTM D5185m >10	1	1	<1
Nickel	ppm	ASTM D5185m >5	<1	<1	<1
Titanium	ppm	ASTM D5185m >15	<1	<1	<1
Silver	ppm	ASTM D5185m >2	4	0	0
Aluminum	ppm	ASTM D5185m >75	2	2	2
Lead	ppm	ASTM D5185m >10	2	0	0
Copper	ppm	ASTM D5185m >75	3	2	<1
Tin	ppm	ASTM D5185m >8	<1	<1	0
Vanadium	ppm	ASTM D5185m	0	0	<1
Cadmium	ppm	ASTM D5185m	5	0	0
