OIL ANALYSIS REPORT

Laboratory : WearCheck USA - 501 Madison Ave., Cary, NC 27513
Sample No. : FCH0000031
Lab Number : 06141893
Unique Number : 10966701
Test Package : PLANT

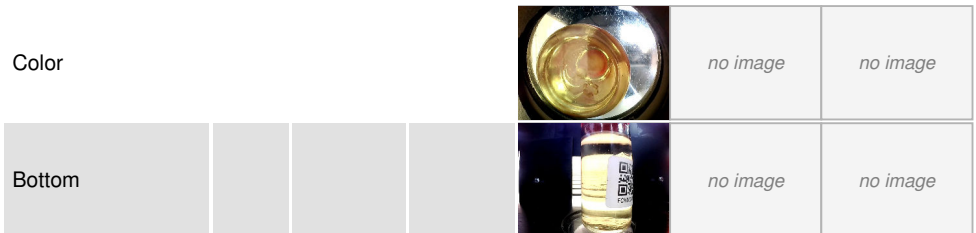
SAMPLE IMAGES	method	limit/base	current	history1	history2
---------------	--------	------------	---------	----------	----------

VISUAL	method	limit/base	current	history1	history2
White Metal	scalar	*Visual	NONE	NONE	---
Yellow Metal	scalar	*Visual	NONE	NONE	---
Precipitate	scalar	*Visual	NONE	NONE	---
Silt	scalar	*Visual	NONE	NONE	---
Debris	scalar	*Visual	NONE	NONE	---
Sand/Dirt	scalar	*Visual	NONE	NONE	---
Appearance	scalar	*Visual	NORML	NORML	---
Odor	scalar	*Visual	NORML	NORML	---
Emulsified Water	scalar	*Visual	>0.1	NEG	---
Free Water	scalar	*Visual		NEG	---
