OIL ANALYSIS REPORT

ATLAS COPCO CAI947165 - BROAD ST CAR WASH

Compressor

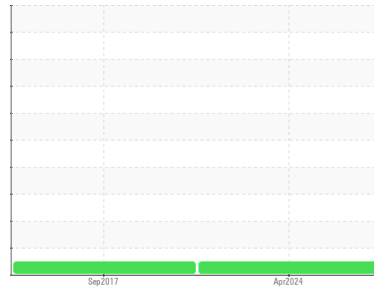
Sample Rating Trend

NORMAL

All component wear rates are normal.

There is no indication of any contamination in the oil.

The AN level is acceptable for this fluid. The condition of the oil is suitable for further service.

Resample at the next service interval to monitor.

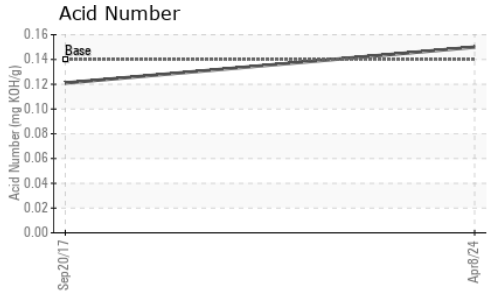
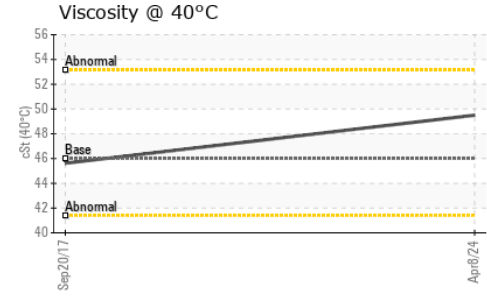
SAMPLE IMAGES	method	limit/base	current	history1	history2
---------------	--------	------------	---------	----------	----------

VISUAL	method	limit/base	current	history1	history2
White Metal	scalar	*Visual	NONE	NONE	---
Yellow Metal	scalar	*Visual	NONE	NONE	---
Precipitate	scalar	*Visual	NONE	NONE	---
Silt	scalar	*Visual	NONE	NONE	---
Debris	scalar	*Visual	NONE	NONE	---
Sand/Dirt	scalar	*Visual	NONE	NONE	---
Appearance	scalar	*Visual	NORML	NORML	---
Odor	scalar	*Visual	NORML	NORML	---
Emulsified Water	scalar	*Visual	>0.1	NEG	---
Free Water	scalar	*Visual		NEG	---
