Machine Id
TB-3 REDUCER
Component
Gearbox
Fluid
CHEVRON MEROPA 220 (20 GAL)

Customer Id: HYDBELFL
Sample No.: ST44546
Lab Number: 06143044
Test Package: IND 2

OIL ANALYSIS REPORT

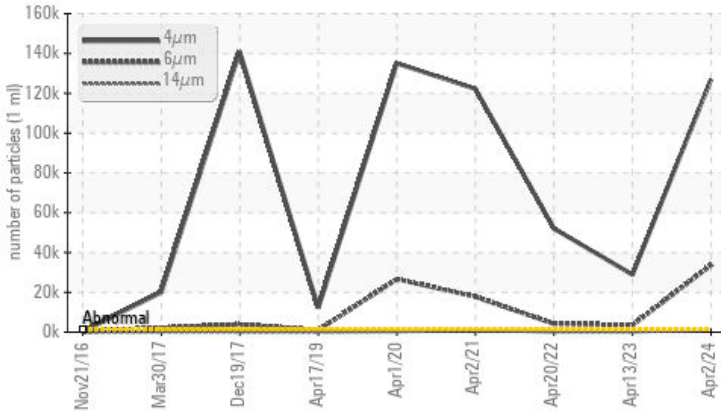
▲ Particle Trend

Sample Status			SEVERE	ABNORMAL	SEVERE
Particles >4µm	ASTM D7647	>1300	▲ 126936	▲ 28881	▲ 52073
Particles >6µm	ASTM D7647	>320	▲ 33667	▲ 3523	▲ 4241
Particles >14µm	ASTM D7647	>80	▲ 1077	▲ 108	● 88
Particles >21µm	ASTM D7647	>20	▲ 185	▲ 25	11
Oil Cleanliness	ISO 4406 (c)	>17/15/13	▲ 24/22/17	▲ 22/19/14	▲ 23/19/14

There is a high amount of particulates (2 to 100 microns in size) present in the oil. The water content is negligible. The system cleanliness code is much higher than the acceptable limit for the target ISO 4406 cleanliness code.

We advise that you check all areas where contaminants can enter the system. We advise that you perform a filter service, and use off-line filtration to improve the cleanliness of the system fluid. The air breather requires service. If unrated, we recommend that you replace with a suitable micron rated and/or desiccant air breather. If rated, we recommend that you service/replace the breather. Resample in 30-45 days to monitor this situation.

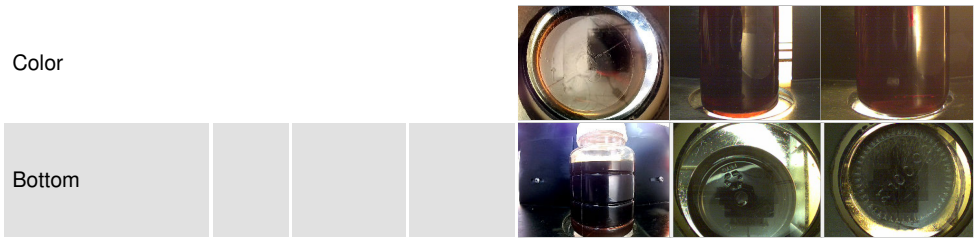
SAMPLE IMAGES	method	limit/base	current	history1	history2
---------------	--------	------------	---------	----------	----------

VISUAL	method	limit/base	current	history1	history2
White Metal	scalar	*Visual	NONE	NONE	LIGHT
Yellow Metal	scalar	*Visual	NONE	NONE	NONE
Precipitate	scalar	*Visual	NONE	NONE	NONE
Silt	scalar	*Visual	NONE	NONE	NONE
Debris	scalar	*Visual	NONE	NONE	NONE
Sand/Dirt	scalar	*Visual	NONE	NONE	NONE
Appearance	scalar	*Visual	NORML	NORML	NORML
Odor	scalar	*Visual	NORML	NORML	NORML
Emulsified Water	scalar	*Visual	>0.2	NEG	NEG
Free Water	scalar	*Visual		NEG	NEG
