FUEL REPORT

Machine Id
MTU 3 BR
 Component
Diesel Fuel
 Fluid
DIESEL FUEL No. 2 (--- GAL)

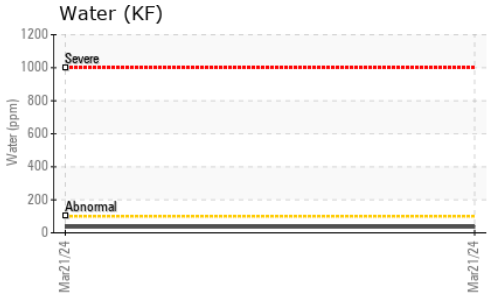
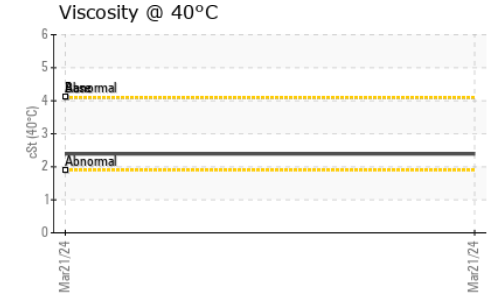
Color

Moderate concentration of visible dirt/debris present in the fuel. The water content is negligible. There is no bacteria or fungus (yeast and/or mold) present in the sample.
