# OIL ANALYSIS REPORT

**Book Saw Infeed Lift Table Hydraulic Unit (S/N TR110B13)**

**Hydraulic System**

**AW HYDRAULIC OIL ISO 68 (--- GAL)**

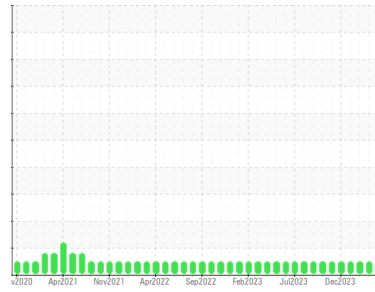
Sample Rating Trend

**NORMAL**

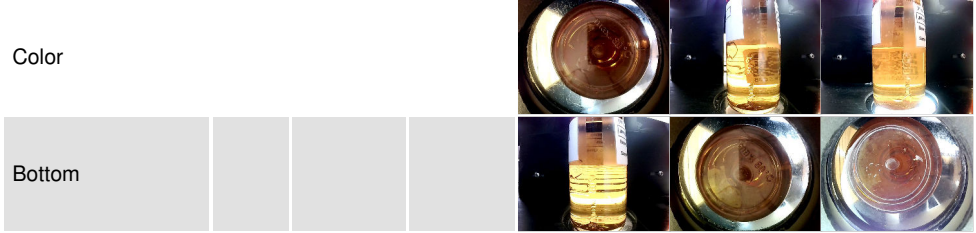
SAMPLE IMAGES	method	limit/base	current	history1	history2
---------------	--------	------------	---------	----------	----------

VISUAL	method	limit/base	current	history1	history2
White Metal	scalar	*Visual	NONE	NONE	NONE
Yellow Metal	scalar	*Visual	NONE	NONE	NONE
Precipitate	scalar	*Visual	NONE	NONE	NONE
Silt	scalar	*Visual	NONE	NONE	NONE
Debris	scalar	*Visual	NONE	NONE	NONE
Sand/Dirt	scalar	*Visual	NONE	NONE	NONE
Appearance	scalar	*Visual	NORML	NORML	NORML
Odor	scalar	*Visual	NORML	NORML	NORML
Emulsified Water	scalar	*Visual	>0.05	NEG	NEG
Free Water	scalar	*Visual		NEG	NEG

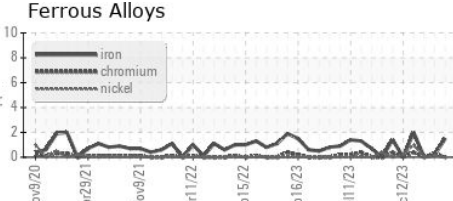
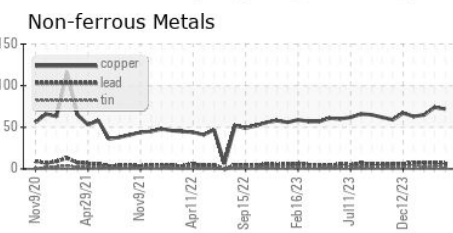
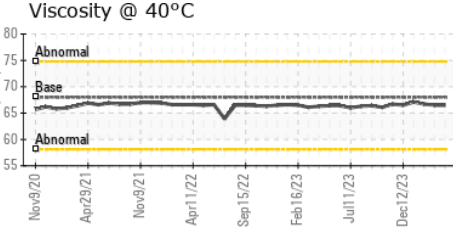
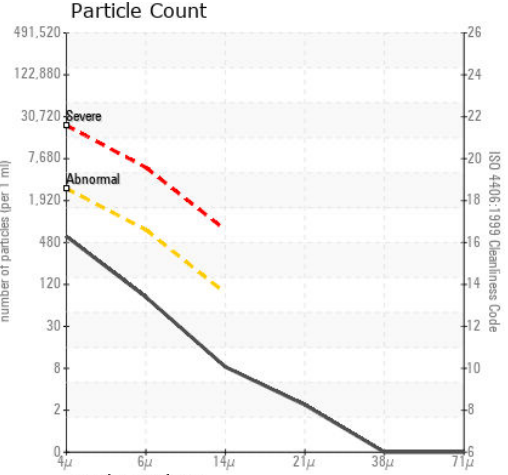
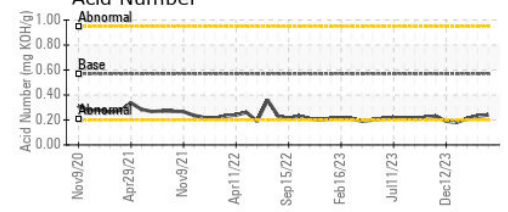
## GRAPHS

All component wear rates are normal.

The system cleanliness is acceptable for your target ISO 4406 cleanliness code. The system and fluid cleanliness is acceptable.

The AN level is acceptable for this fluid. The condition of the oil is suitable for further service.

Little or no information is provided as to the component and lubricant being tested. Recommendations are therefore generic in nature and may not apply to the current application. Please forward information as to equipment type, reservoir capacity, lubricant type and any pertinent information to allow for a more accurate assessment. Resample at the next service interval to monitor. NOTE: Please provide information regarding reservoir capacity, filter type and micron rating with next sample. Please specify the brand, type, and viscosity of the oil on your next sample.
