OIL ANALYSIS REPORT

Machine Id
4539-1
 Component
1 Gearbox
 Fluid
CASTROL RO 150 (--- GAL)

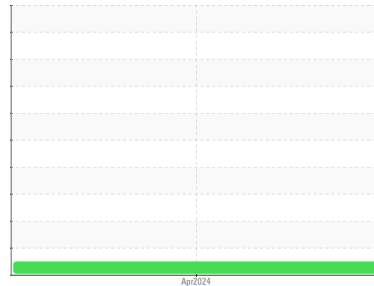
Sample Rating Trend

NORMAL

Resample at the next service interval to monitor.

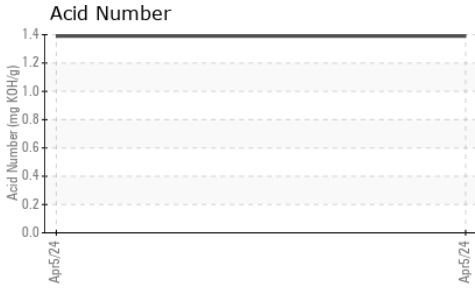
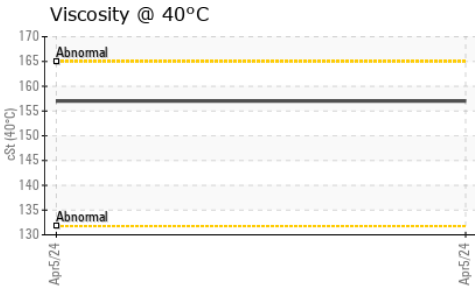
GRAPHS

All component wear rates are normal.

There is no indication of any contamination in the oil.

The AN level is acceptable for this fluid. The condition of the oil is suitable for further service.
