OIL ANALYSIS REPORT

EX-401

Hydraulic System

CAT HYDO (--- GAL)

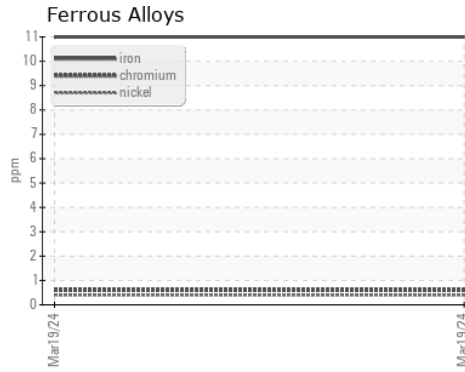
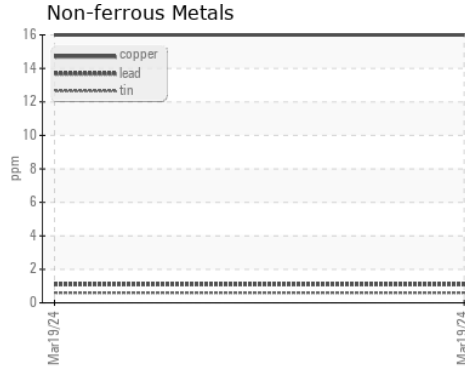
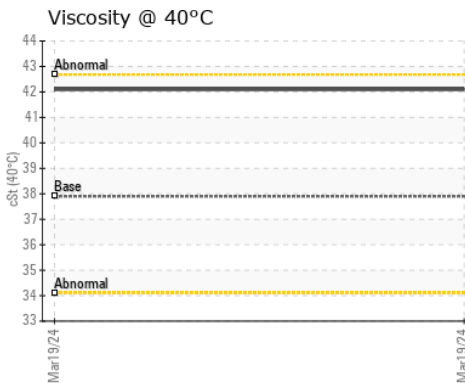
GRAPHS

All component wear rates are normal.

There is no indication of any contamination in the fluid.

The condition of the fluid is acceptable for the time in service.

Resample at the next service interval to monitor.
