OIL ANALYSIS REPORT

Laboratory : WearCheck USA - 501 Madison Ave., Cary, NC 27513
Sample No. : WC0905043 **Received** : 15 Apr 2024
Lab Number : **06149430** **Tested** : 19 Apr 2024
Unique Number : 10979508 **Diagnosed** : 19 Apr 2024 - Don Baldrige
Test Package : FLEET (Additional Tests: FuelDilution, PercentFuel)

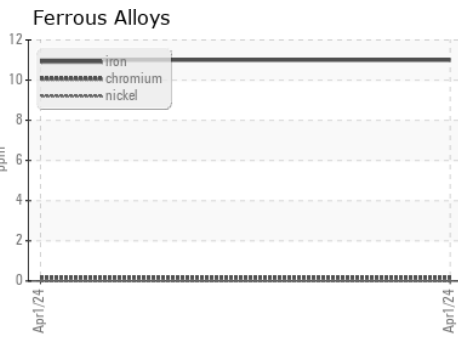
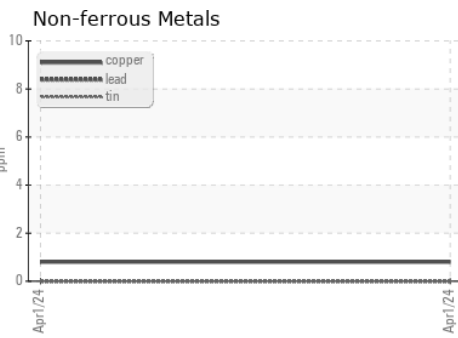
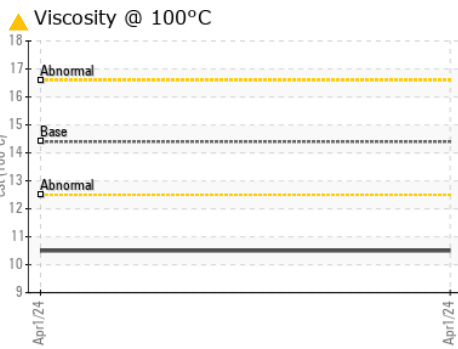
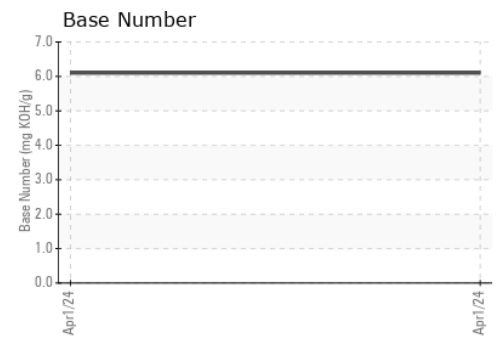
GRAPHS

FLUID PROPERTIES	method	limit/base	current	history1	history2	
Visc @ 100°C	cSt	ASTM D445	14.4	▲ 10.5	---	---

Action	Status	Date	Done By	Description
Change Fluid	---	---	?	Oil and filter change at the time of sampling has been noted.
Change Filter	---	---	?	Oil and filter change at the time of sampling has been noted.
Resample	---	---	?	We recommend an early resample to monitor this condition.
Check Fuel/injector System	---	---	?	We advise that you check the fuel injection system.
