OIL ANALYSIS REPORT

Machine Id
VOLVO A45G 353636
 Component
Front Axle
 Fluid
VOLVO SUPER GEAR OIL 75W-80-GO102 (--- GAL)

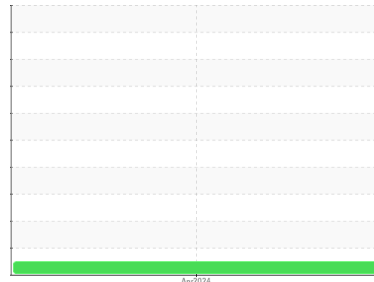
Sample Rating Trend

NORMAL

All component wear rates are normal.

There is no indication of any contamination in the oil.

The condition of the oil is acceptable for the time in service.

Resample at the next service interval to monitor.

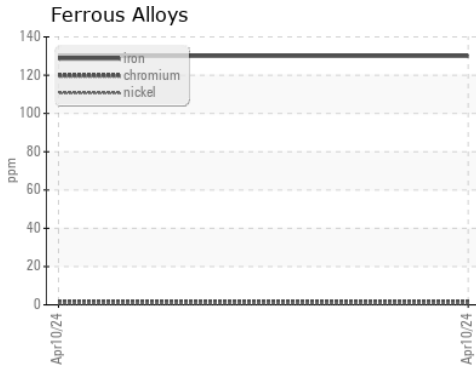
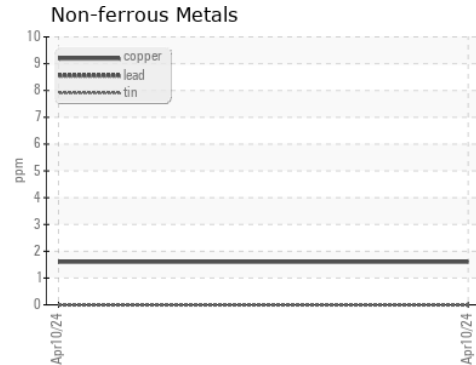
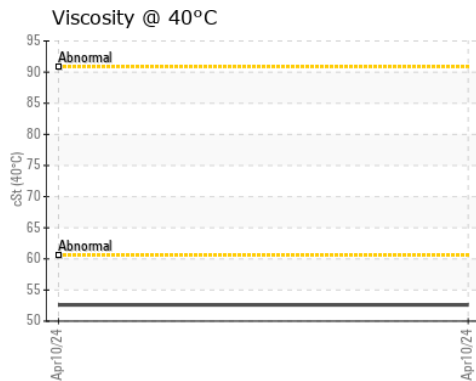
GRAPHS

| WEAR METALS | | method | limit/base | current | history1 | history2 |
|---|---|---|---|---|---|---|
| Iron | ppm | ASTM D5185m | >900 | 130 | --- | --- |

| FLUID PROPERTIES | method | limit/base | current | history1 | history2 |
|---|---|---|---|---|---|
| Visc @ 40°C | cSt | ASTM D445 | 52.6 | --- | --- |
