OIL ANALYSIS REPORT

Area
CHEATHAM ANNEX
 Machine Id
1723 CRANE 1B (S/N 62510225)
 Component
Gearbox
 Fluid
SHELL OMALA S4 WE 220 (--- GAL)

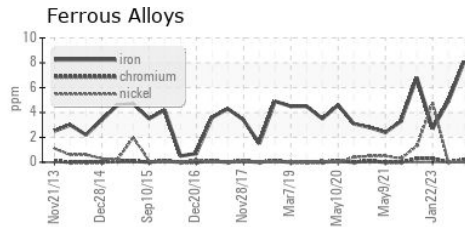
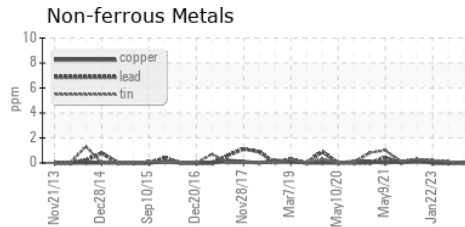
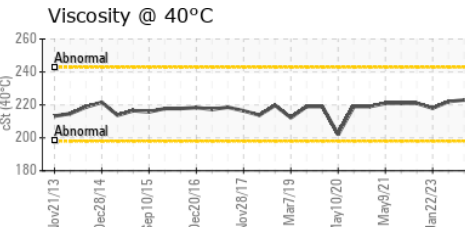
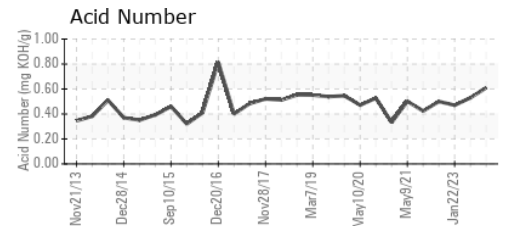
GRAPHS

All component wear rates are normal.

The AN level is acceptable for this fluid. The condition of the oil is suitable for further service.

Resample at the next service interval to monitor.
