OIL ANALYSIS REPORT

Area
CHEATHAM ANNEX
 Machine Id
2A 1728 CRANE 2A (S/N 62510226)
 Component
Gearbox
 Fluid
SHELL OMALA S4 WE 220 (--- GAL)

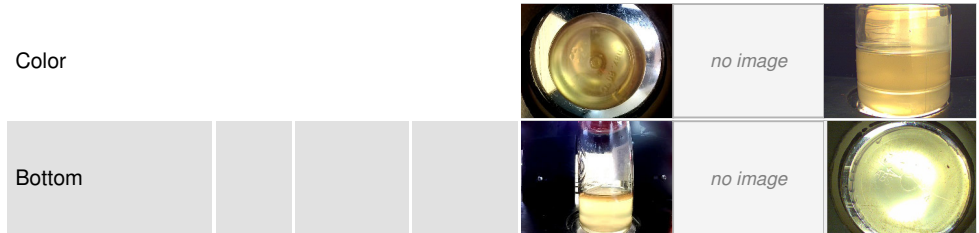
SAMPLE IMAGES	method	limit/base	current	history1	history2
---------------	--------	------------	---------	----------	----------

VISUAL	method	limit/base	current	history1	history2
White Metal	scalar	*Visual	NONE	NONE	NONE
Yellow Metal	scalar	*Visual	NONE	NONE	NONE
Precipitate	scalar	*Visual	NONE	NONE	NONE
Silt	scalar	*Visual	NONE	NONE	NONE
Debris	scalar	*Visual	NONE	NONE	NONE
Sand/Dirt	scalar	*Visual	NONE	NONE	NONE
Appearance	scalar	*Visual	NORML	NORML	NORML
Odor	scalar	*Visual	NORML	NORML	NORML
Emulsified Water	scalar	*Visual	>0.2	NEG	NEG
Free Water	scalar	*Visual		NEG	NEG
