OIL ANALYSIS REPORT

2A 2AHW CRANE 2A (S/N 62510226)

Gearbox

SHELL OMALA S4 WE 220 (--- GAL)

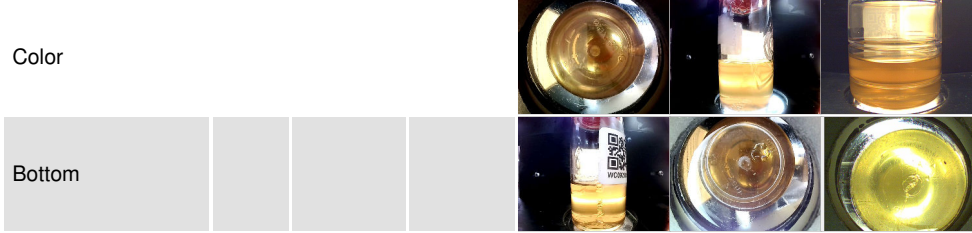
SAMPLE IMAGES	method	limit/base	current	history1	history2
---------------	--------	------------	---------	----------	----------

VISUAL	method	limit/base	current	history1	history2
White Metal	scalar	*Visual	NONE	NONE	NONE
Yellow Metal	scalar	*Visual	NONE	NONE	NONE
Precipitate	scalar	*Visual	NONE	NONE	NONE
Silt	scalar	*Visual	NONE	NONE	NONE
Debris	scalar	*Visual	NONE	NONE	NONE
Sand/Dirt	scalar	*Visual	NONE	NONE	NONE
Appearance	scalar	*Visual	NORML	NORML	NORML
Odor	scalar	*Visual	NORML	NORML	NORML
Emulsified Water	scalar	*Visual	>0.2	NEG	NEG
Free Water	scalar	*Visual		NEG	NEG
