OIL ANALYSIS REPORT

SULLIVAN PALATEK 23CE003876 - COYNE MACHINE

Compressor

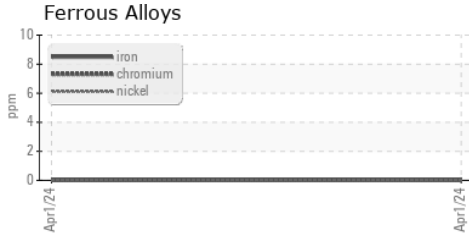
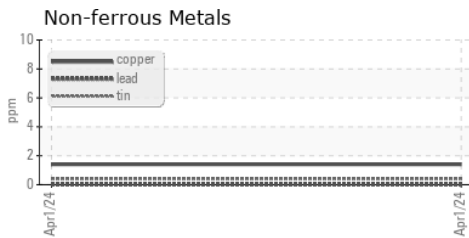
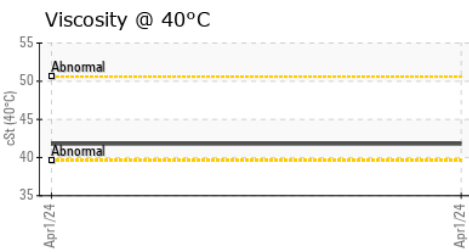
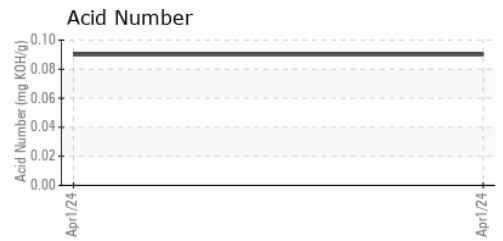
GRAPHS

All component wear rates are normal.

There is no indication of any contamination in the oil.

The AN level is acceptable for this fluid. The condition of the oil is suitable for further service.

Resample at the next service interval to monitor.
