OIL ANALYSIS REPORT

Laboratory : WearCheck USA - 501 Madison Ave., Cary, NC 27513
Sample No. : KCPA012522 **Received** : 10 May 2024
Lab Number : 06175489 **Tested** : 14 May 2024
Unique Number : 11021542 **Diagnosed** : 14 May 2024 - Angela Borella
Test Package : IND 2 (Additional Tests: KF, PrtCount)

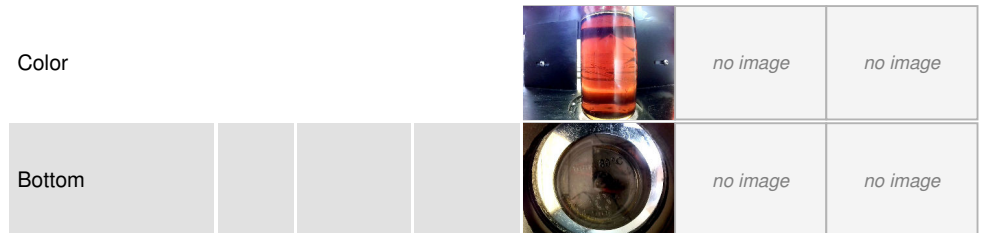
SAMPLE IMAGES	method	limit/base	current	history1	history2
---------------	--------	------------	---------	----------	----------

VISUAL	method	limit/base	current	history1	history2
White Metal	scalar	*Visual	NONE	NONE	---
Yellow Metal	scalar	*Visual	NONE	NONE	---
Precipitate	scalar	*Visual	NONE	NONE	---
Silt	scalar	*Visual	NONE	NONE	---
Debris	scalar	*Visual	NONE	NONE	---
Sand/Dirt	scalar	*Visual	NONE	NONE	---
Appearance	scalar	*Visual	NORML	NORML	---
Odor	scalar	*Visual	NORML	NORML	---
Emulsified Water	scalar	*Visual	>0.05	NEG	---
Free Water	scalar	*Visual		NEG	---
