OIL ANALYSIS REPORT

Laboratory : WearCheck USA - 501 Madison Ave., Cary, NC 27513
Sample No. : KCPA012723 **Received** : 10 May 2024
Lab Number : **06176137** **Tested** : 14 May 2024
Unique Number : 11022190 **Diagnosed** : 14 May 2024 - Doug Bogart
Test Package : IND 2 (Additional Tests: KF, PrtCount)

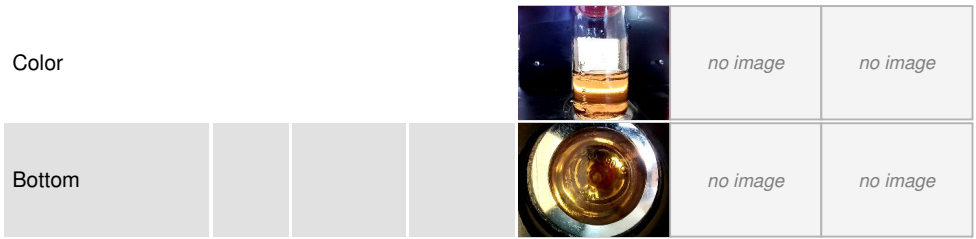
SAMPLE IMAGES	method	limit/base	current	history1	history2
---------------	--------	------------	---------	----------	----------

VISUAL	method	limit/base	current	history1	history2
White Metal	scalar	*Visual	NONE	NONE	---
Yellow Metal	scalar	*Visual	NONE	NONE	---
Precipitate	scalar	*Visual	NONE	NONE	---
Silt	scalar	*Visual	NONE	NONE	---
Debris	scalar	*Visual	NONE	NONE	---
Sand/Dirt	scalar	*Visual	NONE	NONE	---
Appearance	scalar	*Visual	NORML	NORML	---
Odor	scalar	*Visual	NORML	NORML	---
Emulsified Water	scalar	*Visual	>0.05	NEG	---
Free Water	scalar	*Visual		NEG	---

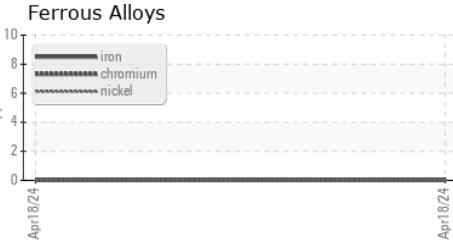
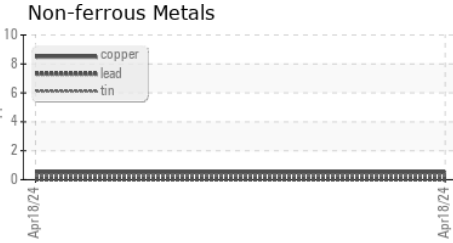
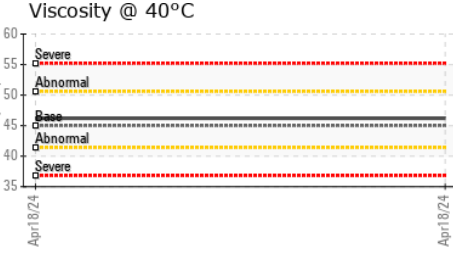
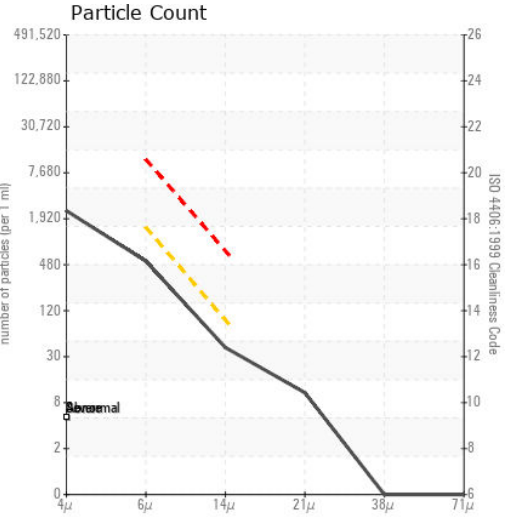
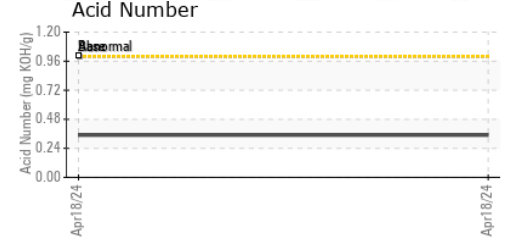
GRAPHS

FLUID PROPERTIES	method	limit/base	current	history1	history2
Visc @ 40°C	cSt	ASTM D445	45	46.2	---
