OIL ANALYSIS REPORT

Machine Id
ALSTOM R019
 Component
Front Left Gearbox
 Fluid
TOTAL CARTER SH 220 (3 GAL)

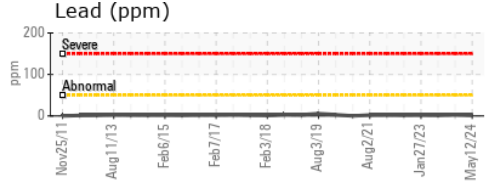
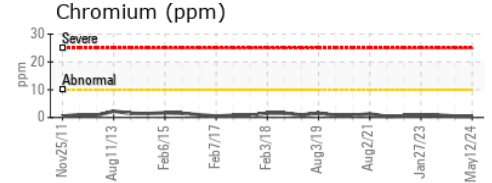
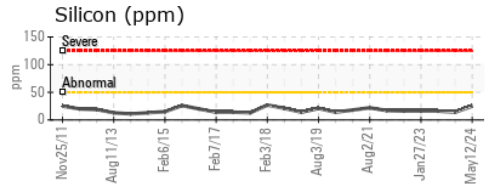
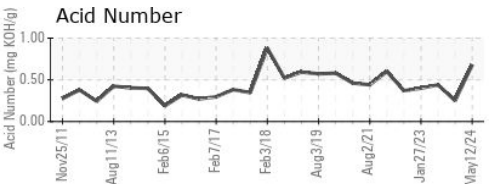
GRAPHS

All component wear rates are normal.

There is no indication of any contamination in the oil.

The AN level is acceptable for this fluid. The condition of the oil is suitable for further service.

Resample at the next service interval to monitor.
