OIL ANALYSIS REPORT

Machine Id
ALSTOM R100
 Component
Gearbox
 Fluid
TOTAL CARTER SH 220 (3 GAL)

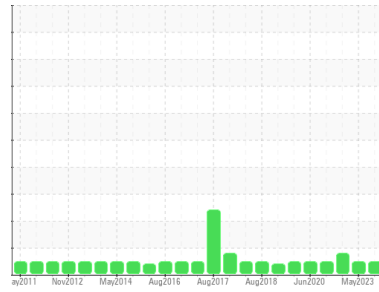
Sample Rating Trend

NORMAL

Resample at the next service interval to monitor.

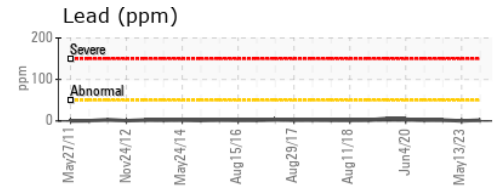
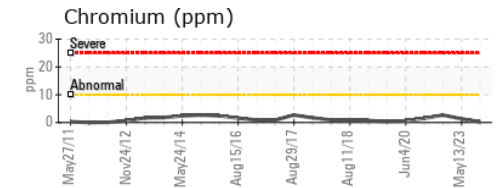
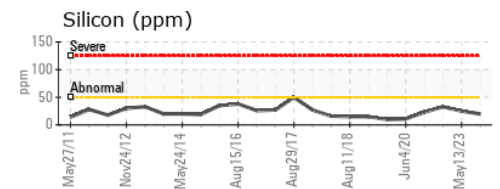
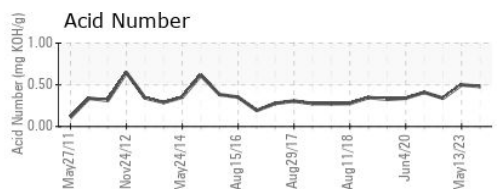
GRAPHS

All component wear rates are normal.

There is no indication of any contamination in the oil.

The AN level is acceptable for this fluid. The condition of the oil is suitable for further service.
