PROBLEM SUMMARY

Area
SMART OIL 6000
Machine Id
HERTZ VD024924 - PIONEER METAL
Component
Compressor

OIL ANALYSIS REPORT

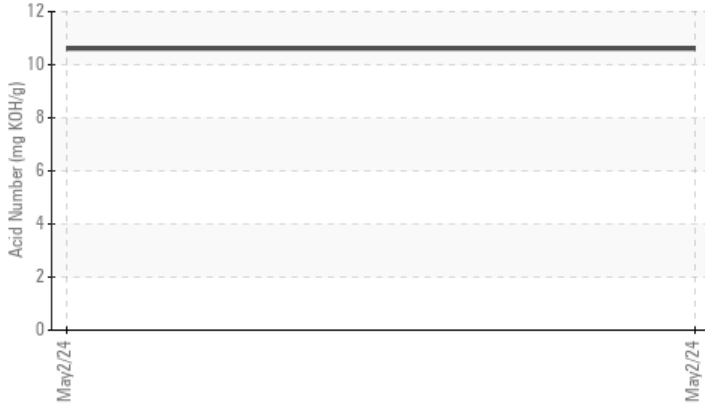
▲ Acid Number

The AN level is above the recommended limit. The oil viscosity is higher than normal. TAN level indicates possible presence of varnish. The oil is no longer serviceable.

Acid Number (AN)	mg KOH/g	ASTM D8045		▲ 10.61	---	---
------------------	----------	------------	--	----------------	-----	-----

We advise that you check for a possible overheat condition. Recommend drain oil if not already done and flush with cleaner before refilling with oil. We recommend an early resample to monitor this condition.
