OIL ANALYSIS REPORT

Machine Id
ALSTOM R004
 Component
Gearbox
 Fluid
TOTAL CARTER SH 220 (3 GAL)

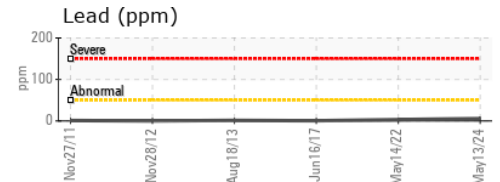
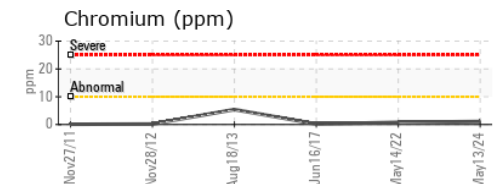
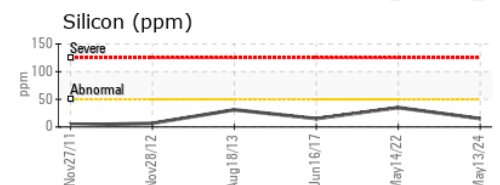
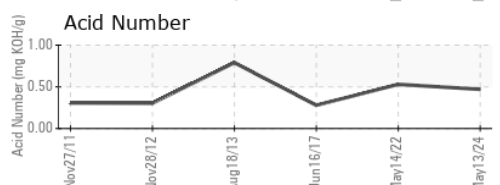
GRAPHS

All component wear rates are normal.

There is no indication of any contamination in the oil.

The AN level is acceptable for this fluid. The condition of the oil is suitable for further service.

Resample at the next service interval to monitor.
