OIL ANALYSIS REPORT

Machine Id
VOLVO A25G 752910
 Component
Drop Box
 Fluid
VOLVO SUPER GEAR OIL 75W-80-GO102 (--- GAL)

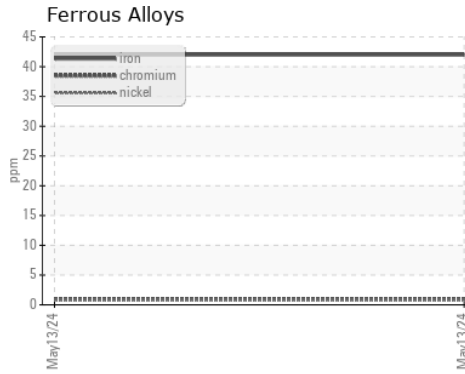
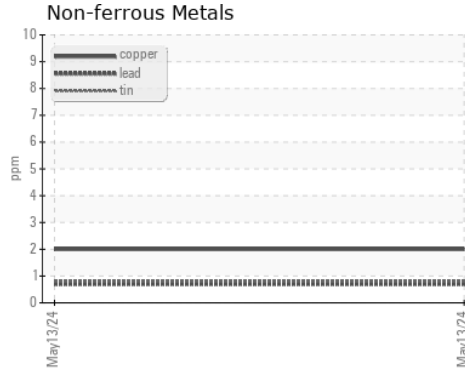
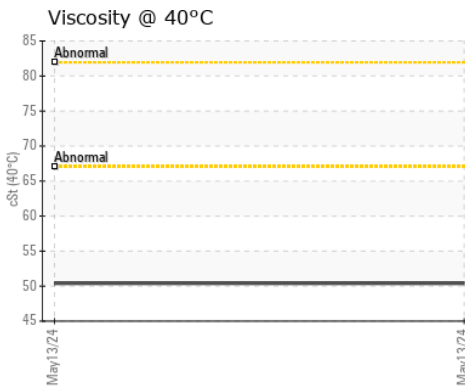
GRAPHS

All component wear rates are normal.

There is no indication of any contamination in the oil.

The condition of the oil is acceptable for the time in service.

Resample at the next service interval to monitor.
