# OIL ANALYSIS REPORT

**Laboratory** : WearCheck USA - 501 Madison Ave., Cary, NC 27513  
**Sample No.** : KCPA014481 **Received** : 16 May 2024  
**Lab Number** : **06182014** **Tested** : 20 May 2024  
**Unique Number** : 11033340 **Diagnosed** : 20 May 2024 - Don Baldrige  
**Test Package** : IND 2 ( Additional Tests: KF, PrtCount )

**GOOD SAMARITAN HOSPITAL**  
 2425 SAMARITAN DR  
 SAN JOSE, CA  
 US 95124  
 Contact: TOM SANPAULO  
 tom.sanpaulo2@hcahealthcare.com

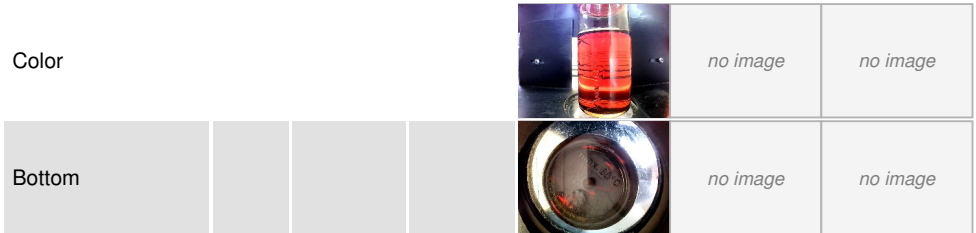
SAMPLE IMAGES	method	limit/base	current	history1	history2
---------------	--------	------------	---------	----------	----------

VISUAL	method	limit/base	current	history1	history2
White Metal	scalar	*Visual	NONE	<b>NONE</b>	---
Yellow Metal	scalar	*Visual	NONE	<b>NONE</b>	---
Precipitate	scalar	*Visual	NONE	<b>NONE</b>	---
Silt	scalar	*Visual	NONE	<b>NONE</b>	---
Debris	scalar	*Visual	NONE	<b>NONE</b>	---
Sand/Dirt	scalar	*Visual	NONE	<b>NONE</b>	---
Appearance	scalar	*Visual	NORML	<b>NORML</b>	---
Odor	scalar	*Visual	NORML	<b>NORML</b>	---
Emulsified Water	scalar	*Visual	>0.05	<b>NEG</b>	---
Free Water	scalar	*Visual		<b>NEG</b>	---
