OIL ANALYSIS REPORT

Machine Id
KAESER SK 15T 8368276 (S/N 1443)
 Component
Compressor
 Fluid
KAESER SIGMA (OEM) S-460 (--- GAL)

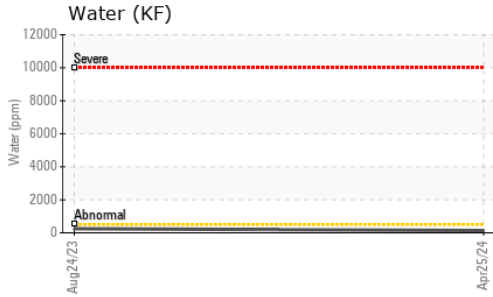
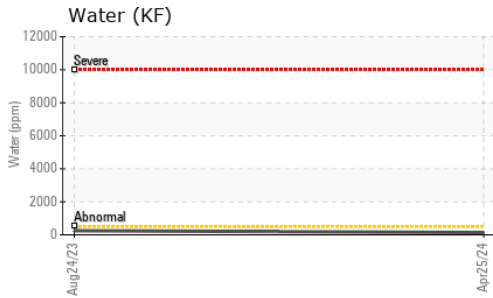
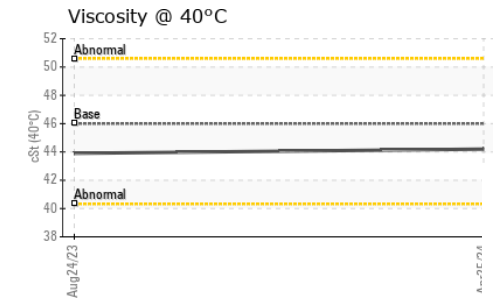
SAMPLE IMAGES	method	limit/base	current	history1	history2
---------------	--------	------------	---------	----------	----------

Moderate concentration of visible dirt/debris present in the oil.

No corrective action is recommended at this time. The filter change at the time of sampling has been noted. Resample at the next service interval to monitor. We were unable to perform a particle count due to a high concentration of particles present in this sample.

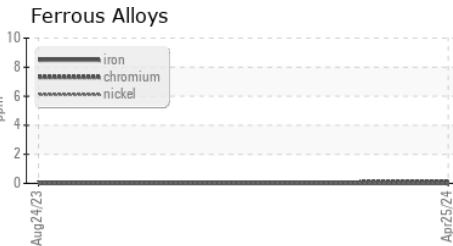
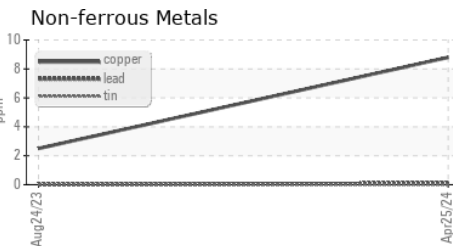
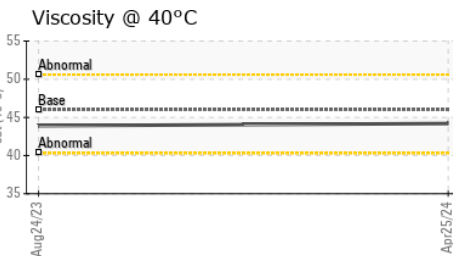
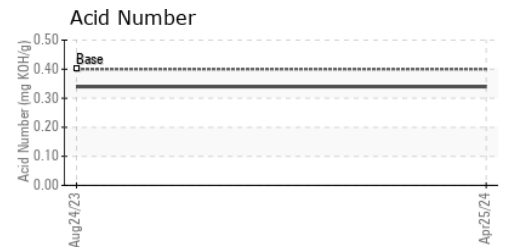
GRAPHS

All component wear rates are normal.

The AN level is acceptable for this fluid. The condition of the oil is suitable for further service.
