Laboratory : WearCheck USA - 501 Madison Ave., Cary, NC 27513
Sample No. : WC0939639 **Received** : 17 May 2024
Lab Number : **06182806** **Tested** : 30 May 2024
Unique Number : 11034132 **Diagnosed** : 30 May 2024 - Jonathan Hester
Test Package : IND 2 (Additional Tests: KF, KV100, PQ, VI)

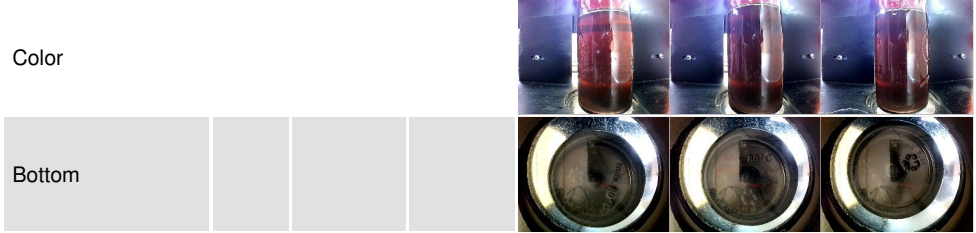
SAMPLE IMAGES	method	limit/base	current	history1	history2
---------------	--------	------------	---------	----------	----------

VISUAL	method	limit/base	current	history1	history2	
White Metal	scalar	*Visual	NONE	MODER	MODER	MODER
Yellow Metal	scalar	*Visual	NONE	NONE	NONE	NONE
Precipitate	scalar	*Visual	NONE	NONE	NONE	NONE
Silt	scalar	*Visual	NONE	MODER	MODER	MODER
Debris	scalar	*Visual	NONE	NONE	NONE	NONE
Sand/Dirt	scalar	*Visual	NONE	NONE	NONE	NONE
Appearance	scalar	*Visual	NORML	NORML	NORML	NORML
Odor	scalar	*Visual	NORML	NORML	NORML	NORML
Emulsified Water	scalar	*Visual	>0.1669	NEG	0.2%	NEG
Free Water	scalar	*Visual		NEG	NEG	NEG
