# OIL ANALYSIS REPORT

Machine Id  
**KAESER AS25T 4938442 (S/N 1362)**  
 Component  
**Compressor**  
 Fluid  
**KAESER SIGMA (OEM) S-460 (--- QTS)**

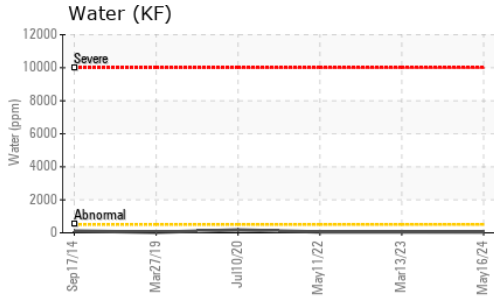
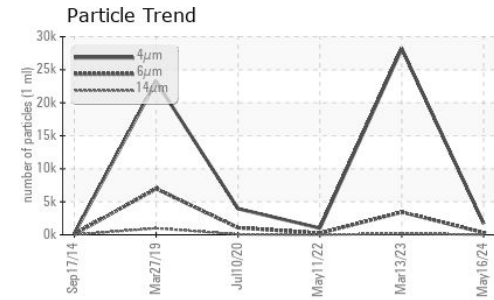
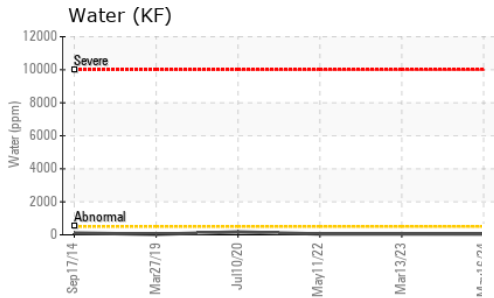
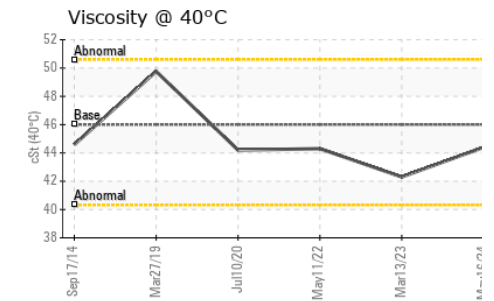
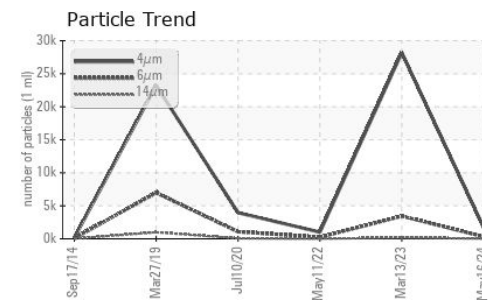
FLUID CLEANLINESS		method	limit/base	current	history1	history2
Particles >4µm		ASTM D7647		<b>1700</b>	28182	1005
Particles >6µm		ASTM D7647	>1300	<b>316</b>	▲ 3437	251
Particles >14µm		ASTM D7647	>80	<b>28</b>	▲ 170	14
Particles >21µm		ASTM D7647	>20	<b>6</b>	▲ 64	4
Particles >38µm		ASTM D7647	>4	<b>0</b>	3	0
Particles >71µm		ASTM D7647	>3	<b>0</b>	0	0
Oil Cleanliness		ISO 4406 (c)	>--/17/13	<b>18/15/12</b>	▲ 22/19/15	17/15/11

FLUID DEGRADATION		method	limit/base	current	history1	history2
Acid Number (AN)	mg KOH/g	ASTM D8045	0.4	<b>0.39</b>	0.35	0.37

FLUID PROPERTIES	method	limit/base	current	history1	history2
Visc @ 40°C	cSt	ASTM D445	46	44.4	42.3

Resample at the next service interval to monitor.
