HERTZ VD012574 - FESCO SYSTEMS

Compressor

OIL ANALYSIS REPORT

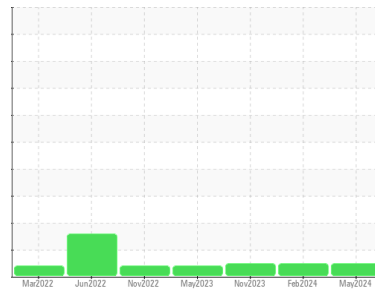
Sample Rating Trend

NORMAL

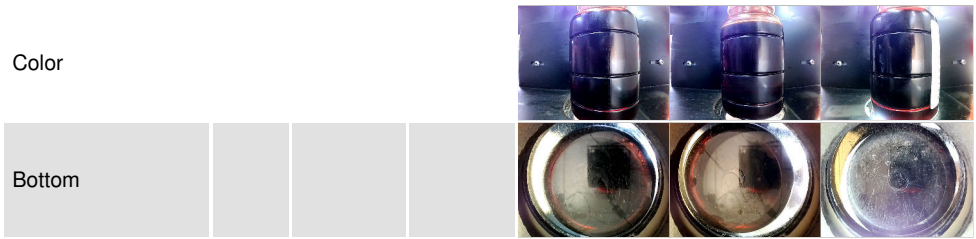
SAMPLE IMAGES	method	limit/base	current	history1	history2
---------------	--------	------------	---------	----------	----------

VISUAL	method	limit/base	current	history1	history2
White Metal	scalar	*Visual	NONE	NONE	NONE
Yellow Metal	scalar	*Visual	NONE	NONE	NONE
Precipitate	scalar	*Visual	NONE	NONE	NONE
Silt	scalar	*Visual	NONE	NONE	NONE
Debris	scalar	*Visual	NONE	MODER	LIGHT
Sand/Dirt	scalar	*Visual	NONE	NONE	NONE
Appearance	scalar	*Visual	NORML	NORML	NORML
Odor	scalar	*Visual	NORML	NORML	NORML
Emulsified Water	scalar	*Visual	>0.1	NEG	NEG
Free Water	scalar	*Visual		NEG	NEG

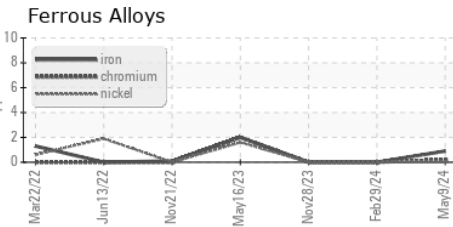
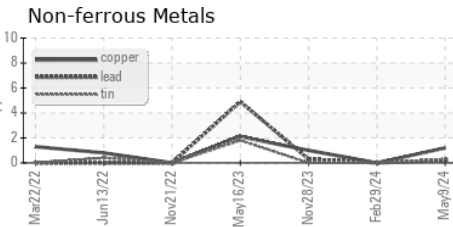
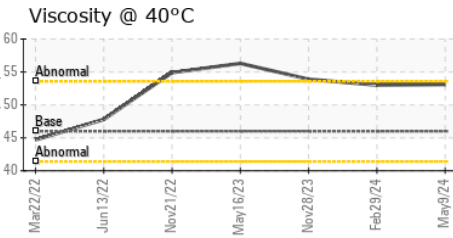
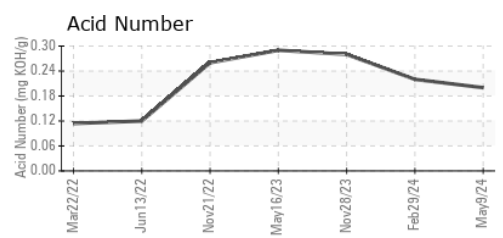
GRAPHS

All component wear rates are normal.

The AN level is acceptable for this fluid. The condition of the oil is suitable for further service.
