OIL ANALYSIS REPORT

Area
CTL74
 Machine Id
CTL 74 EDGE TRIMMER MAIN O/S
 Component
Gearbox
 Fluid
ESSO SPARTAN EP 220 (20 GAL)

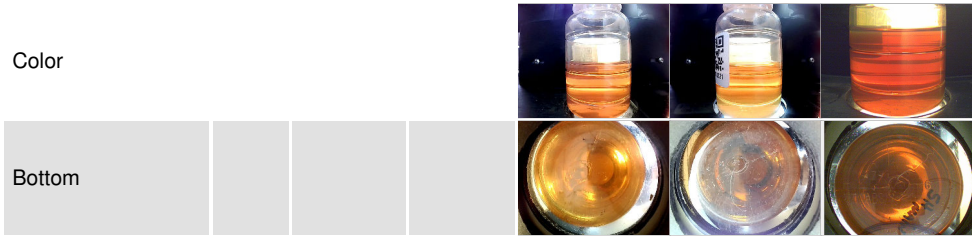
SAMPLE IMAGES	method	limit/base	current	history1	history2
---------------	--------	------------	---------	----------	----------

VISUAL	method	limit/base	current	history1	history2
White Metal	scalar	*Visual	NONE	NONE	NONE
Yellow Metal	scalar	*Visual	NONE	NONE	NONE
Precipitate	scalar	*Visual	NONE	NONE	NONE
Silt	scalar	*Visual	NONE	NONE	NONE
Debris	scalar	*Visual	NONE	NONE	LIGHT
Sand/Dirt	scalar	*Visual	NONE	NONE	NONE
Appearance	scalar	*Visual	NORML	NORML	NORML
Odor	scalar	*Visual	NORML	NORML	NORML
Emulsified Water	scalar	*Visual	>0.2	NEG	NEG
Free Water	scalar	*Visual		NEG	NEG

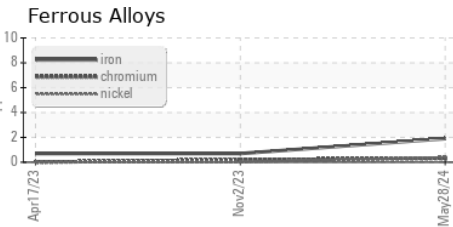
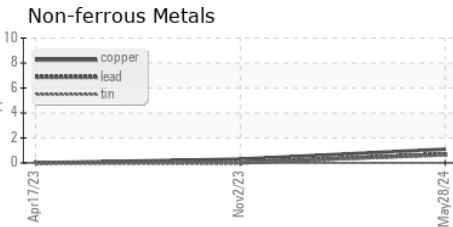
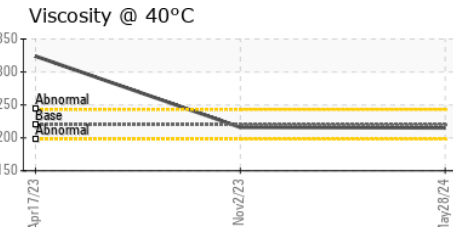
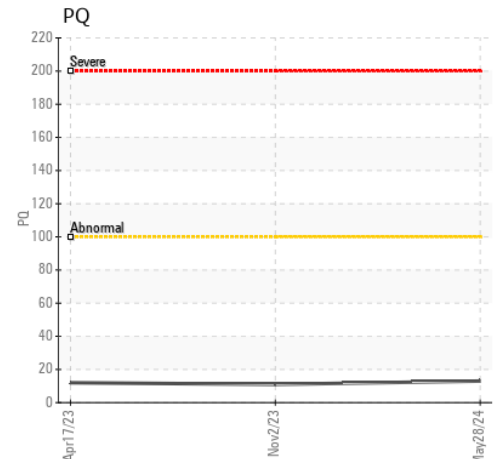
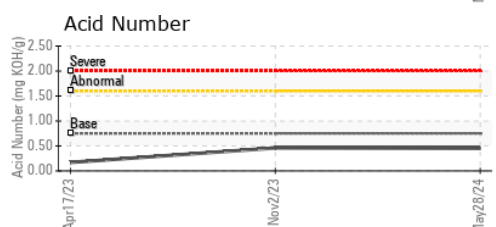
GRAPHS

All component wear rates are normal.

There is no indication of any contamination in the oil.

The AN level is acceptable for this fluid. The condition of the oil is suitable for further service.

Resample at the next service interval to monitor.
