Machine Id
WEST INJECTOR
 Component
Hydraulic System
 Fluid
MOBIL DTE FM 32 (--- GAL)

Customer Id: DANBROMN
 Sample No.: WC0880574
 Lab Number: 06196630
 Test Package: IND 2

OIL ANALYSIS REPORT

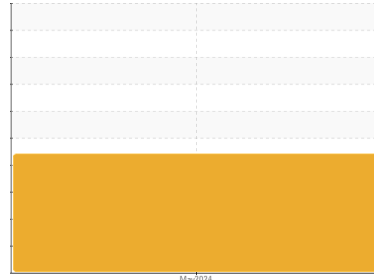
Sample Rating Trend

▲ Particle Trend

Sample Status			SEVERE	---	---
Particles >4µm	ASTM D7647	>5000	▲ 56124	---	---
Particles >6µm	ASTM D7647	>1300	▲ 11163	---	---
Particles >14µm	ASTM D7647	>160	▲ 445	---	---
Particles >21µm	ASTM D7647	>40	▲ 90	---	---
Oil Cleanliness	ISO 4406 (c)	>19/17/14	▲ 23/21/16	---	---

We advise that you check all areas where contaminants can enter the system. We advise that you perform a filter service, and use off-line filtration to improve the cleanliness of the system fluid. The air breather requires service. If unrated, we recommend that you replace with a suitable micron rated and/or desiccant air breather. If rated, we recommend that you service/replace the breather. Resample in 30-45 days to monitor this situation. NOTE: Please provide information regarding reservoir capacity, filter type and micron rating with next sample.

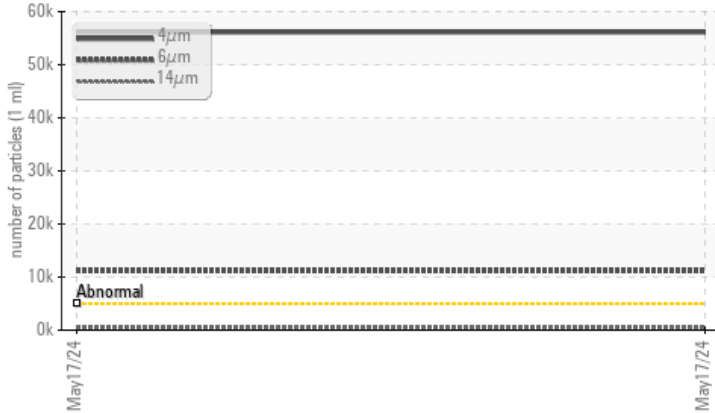
There is a high amount of particulates (2 to 100 microns in size) present in the oil.

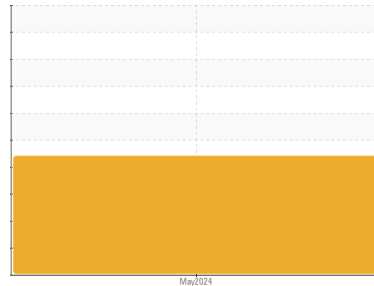
Sample Rating Trend

The AN level is acceptable for this fluid. The oil is still serviceable provided that the contaminant(s) can be reduced to acceptable levels.

We advise that you check all areas where contaminants can enter the system. We advise that you perform a filter service, and use off-line filtration to improve the cleanliness of the system fluid. The air breather requires service. If unrated, we recommend that you replace with a suitable micron rated and/or desiccant air breather. If rated, we recommend that you service/replace the breather. Resample in 30-45 days to monitor this situation. NOTE: Please provide information regarding reservoir capacity, filter type and micron rating with next sample.
