OIL ANALYSIS REPORT

Machine Id
P-2301A GEAR

Component
Gearbox

Fluid
ROYAL PURPLE SYNFILM GT 150 (3 GAL)

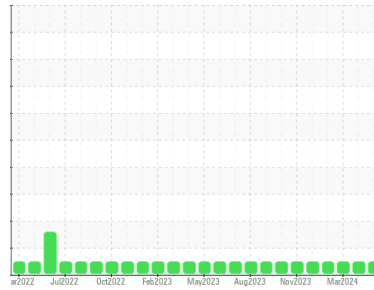
Sample Rating Trend

NORMAL

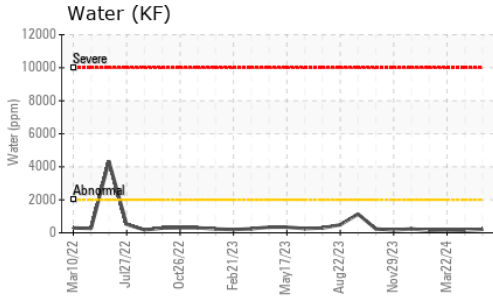
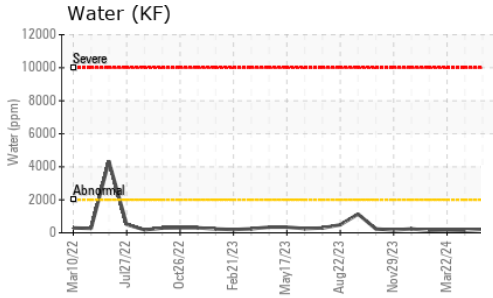
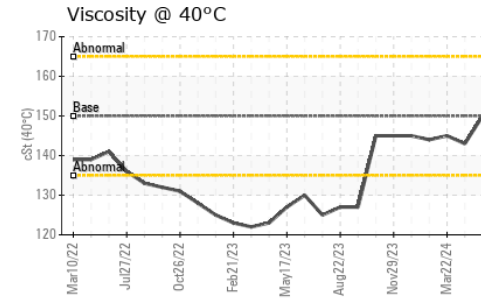
All component wear rates are normal.

The water content is negligible. There is no indication of any contamination in the oil.

The AN level is acceptable for this fluid. The condition of the oil is suitable for further service.

Resample at the next service interval to monitor.

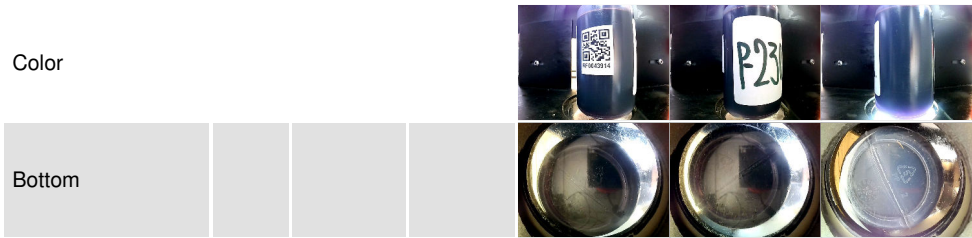
| SAMPLE IMAGES | method | limit/base | current | history1 | history2 |

| VISUAL | | method | limit/base | current | history1 | history2 |
|---|---|---|---|---|---|---|
| Appearance | scalar | *Visual | NORML | NORML | NORML | NORML |
| Odor | scalar | *Visual | NORML | NORML | NORML | NORML |
