OIL ANALYSIS REPORT

ATLAS COPCO CAI701970 - PROPORTION AIR

Compressor

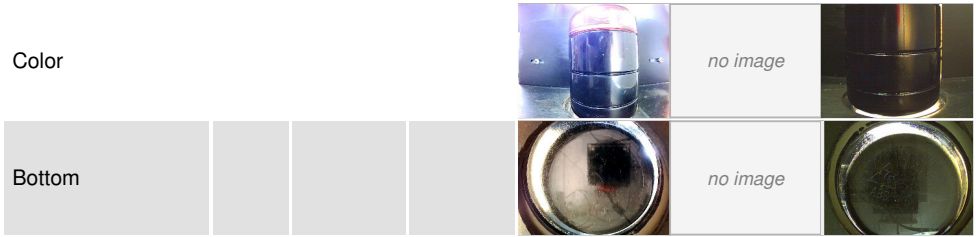
SAMPLE IMAGES	method	limit/base	current	history1	history2
---------------	--------	------------	---------	----------	----------

VISUAL	method	limit/base	current	history1	history2	
White Metal	scalar	*Visual	NONE	NONE	LIGHT	VLITE
Yellow Metal	scalar	*Visual	NONE	NONE	NONE	NONE
Precipitate	scalar	*Visual	NONE	NONE	NONE	NONE
Silt	scalar	*Visual	NONE	NONE	NONE	NONE
Debris	scalar	*Visual	NONE	NONE	NONE	NONE
Sand/Dirt	scalar	*Visual	NONE	NONE	NONE	NONE
Appearance	scalar	*Visual	NORML	NORML	NORML	NORML
Odor	scalar	*Visual	NORML	NORML	NORML	NORML
Emulsified Water	scalar	*Visual	>0.1	NEG	NEG	NEG
Free Water	scalar	*Visual		NEG	NEG	NEG

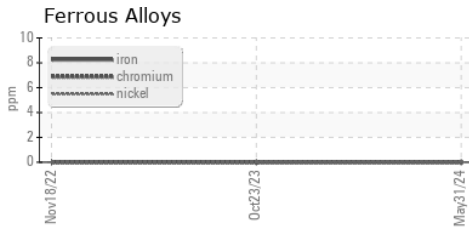
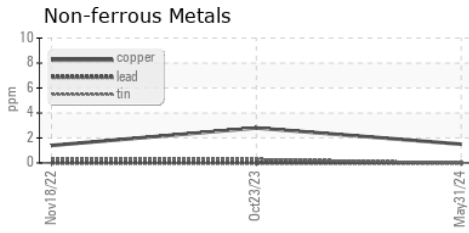
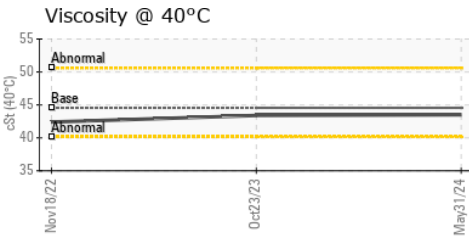
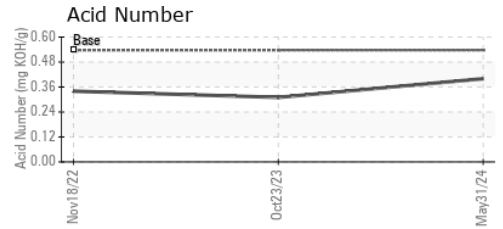
GRAPHS

All component wear rates are normal.

The AN level is acceptable for this fluid. The condition of the oil is suitable for further service.

Resample at the next service interval to monitor.
