OIL ANALYSIS REPORT

CAPL-INLINE SKIN PASS ON MOTOR-GEARBOX

Drive End Gearbox

GEAR OIL (PAO) ISO 220 (--- QTS)

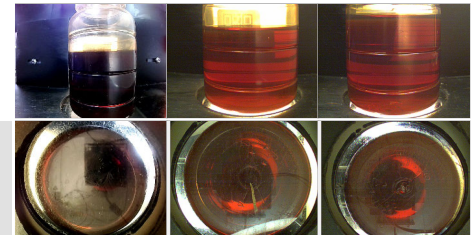
Color

VISUAL	method	limit/base	current	history1	history2
White Metal	scalar	*Visual	NONE	NONE	NONE
Yellow Metal	scalar	*Visual	NONE	NONE	NONE
Precipitate	scalar	*Visual	NONE	NONE	NONE
Silt	scalar	*Visual	NONE	NONE	NONE
Debris	scalar	*Visual	NONE	NONE	NONE
Sand/Dirt	scalar	*Visual	NONE	NONE	NONE
Appearance	scalar	*Visual	NORML	NORML	NORML
Odor	scalar	*Visual	NORML	NORML	NORML
Emulsified Water	scalar	*Visual	>0.2	NEG	NEG
Free Water	scalar	*Visual		NEG	NEG

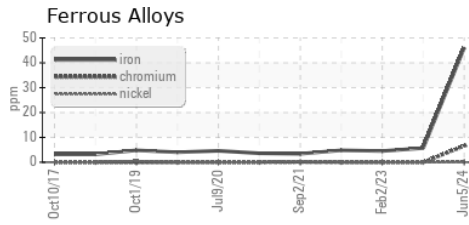
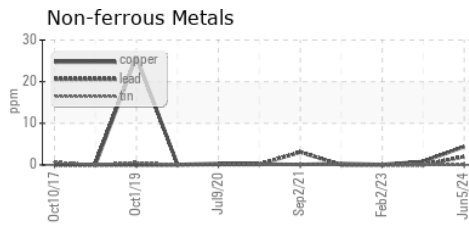
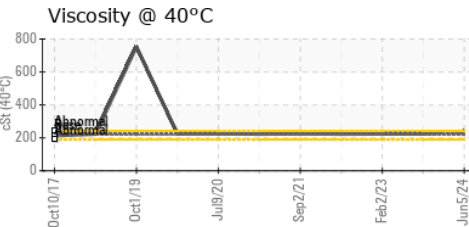
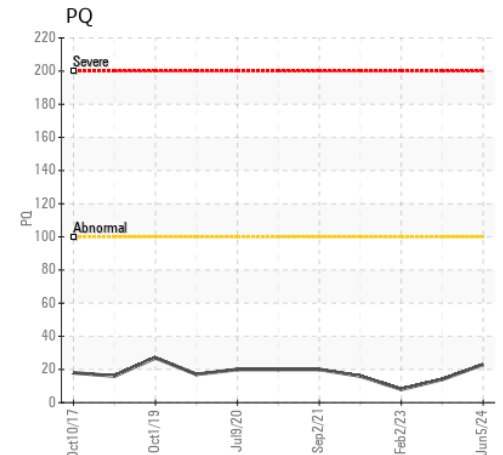
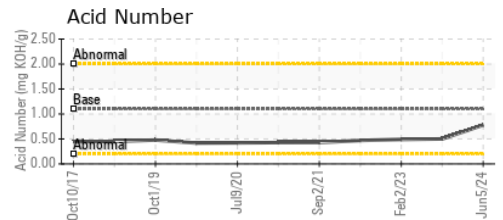
GRAPHS

All component wear rates are normal.

The water content is negligible. There is no indication of any contamination in the oil.

The AN level is acceptable for this fluid. The condition of the oil is suitable for further service.

Resample at the next service interval to monitor.
