Area
HERTZ SMART OIL 6000
Machine Id
HERTZ VD037305
Component
Compressor

OIL ANALYSIS REPORT

Laboratory : WearCheck USA - 501 Madison Ave., Cary, NC 27513
Sample No. : UHK06202922 **Received** : 07 Jun 2024
Lab Number : **06202922** **Tested** : 10 Jun 2024
Unique Number : 11070383 **Diagnosed** : 10 Jun 2024 - Don Baldrige
Test Package : IND 2

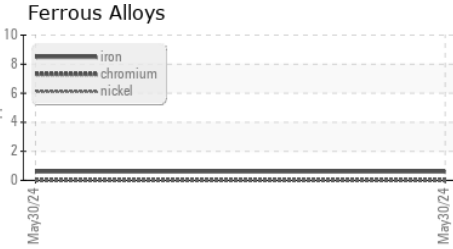
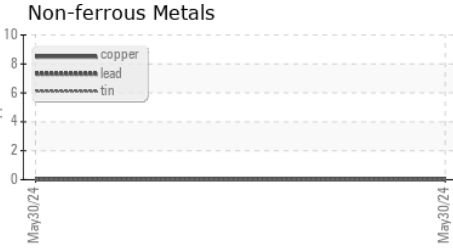
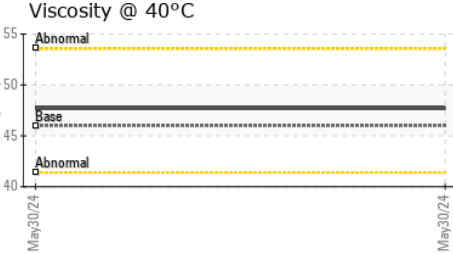
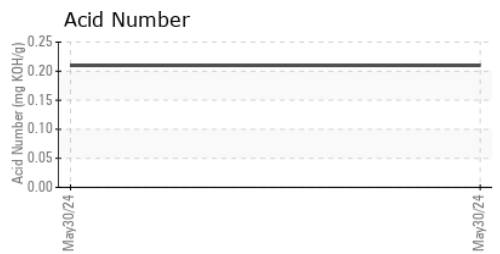
GRAPHS

All component wear rates are normal.

There is no indication of any contamination in the oil.

The AN level is acceptable for this fluid. The condition of the oil is suitable for further service.

Resample at the next service interval to monitor.
