OIL ANALYSIS REPORT

Machine Id
311
 Component
Compressor
 Fluid
VILTER ISO 150 (--- GAL)

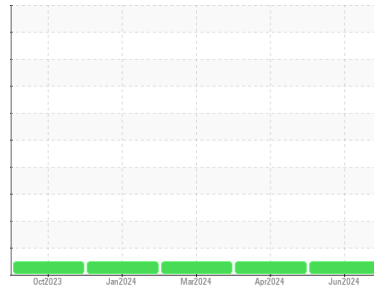
Sample Rating Trend

NORMAL

Resample at the next service interval to monitor.

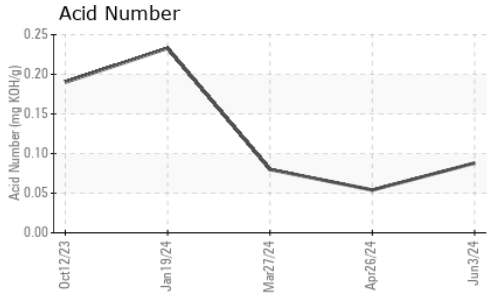
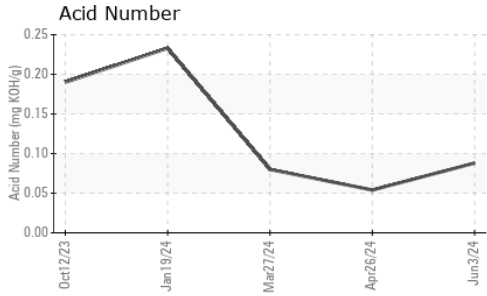
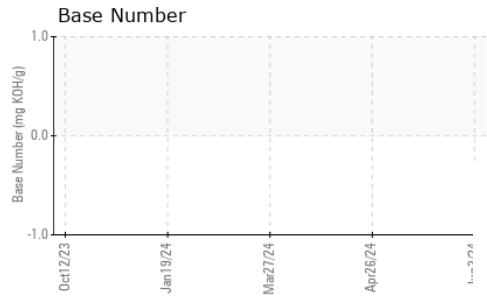
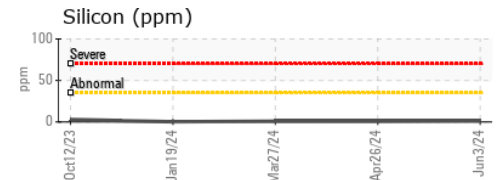
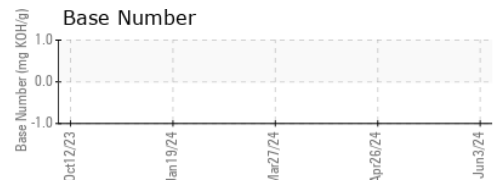
GRAPHS

All component wear rates are normal.

There is no indication of any contamination in the oil.

The AN level is acceptable for this fluid. The condition of the oil is suitable for further service.
