OIL ANALYSIS REPORT

HYDRAULIC PUMP SYS R2100P-A-75BMTCF-H1-G31V-RV6-DMLT

Hydraulic System

MOBIL DTE 25 (210 GAL)

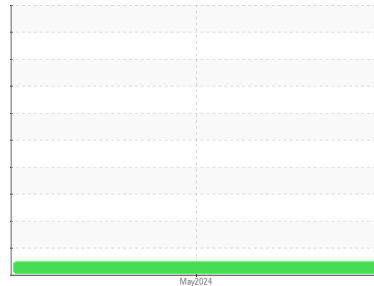
Sample Rating Trend

NORMAL

Resample at the next service interval to monitor.
