OIL ANALYSIS REPORT

Machine Id
79-107
 Component
Rear Left Final Drive
 Fluid
TO-4 (--- GAL)

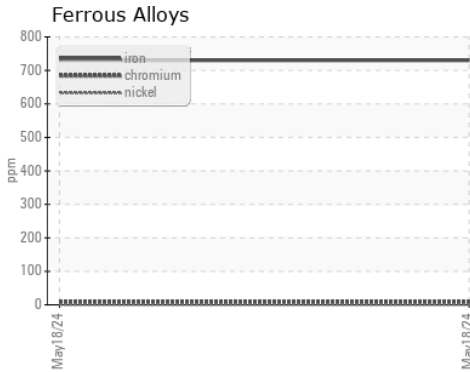
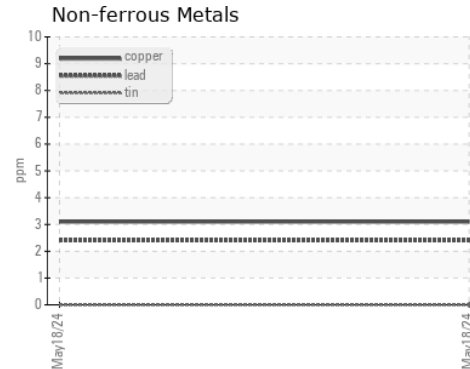
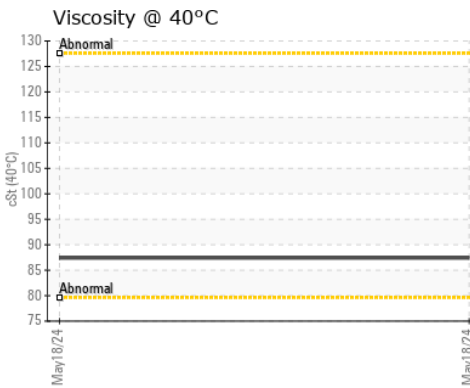
GRAPHS

Metal levels are typical for a new component breaking in.

The oil change at the time of sampling has been noted. Resample at the next service interval to monitor.
