# **OIL ANALYSIS REPORT**

**INTERSTATE WASTE-BRIDGEWATER**

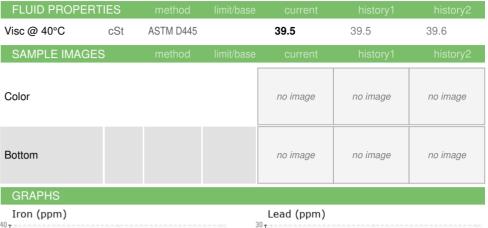
Iron (ppm)	Lead (ppm)	
Severe	30 Severe	
	20+	
Abnormal	Ē 15	
	10 - Abnormal	
	5	
Mar2U/24 Apr13/24	Jun5/24 Mar20/24	5
	~	Ť
Aluminum (ppm)	Chromium (ppm)	
Severe	Severe 25 - Severe	
	20	
Abnormal	E 15 Abnormal	
	10 - Abnormal	
	0	
Mar2U/24 Apr13/24	Jun5/24 Mar20/24	7/6
	~	Ì
Copper (ppm)	Silicon (ppm)	
Severe	50 Severe	
	40	
Abnormal	Abnormal	
4	20   Abnormal	
	0	
Mar20/24 Apr13/24	Jun5/24 Mar20/24	7/6
